**DEPARTMENT OF THE AIR FORCE  
377TH AIR BASE WING (AFGSC)**

**FIRST FIVE-YEAR REVIEW REPORT FOR  
MILITARY MUNITIONS RESPONSE SITES  
AL120 PROXIMITY FUZE RANGE,  
DA130 ARROYO DEL COYOTE DEMOLITION  
AREA,  
ML125 FIELD FIRING RANGE, AND  
PT123 TIJERAS SMALL ARMS RANGE**

**July 2025**

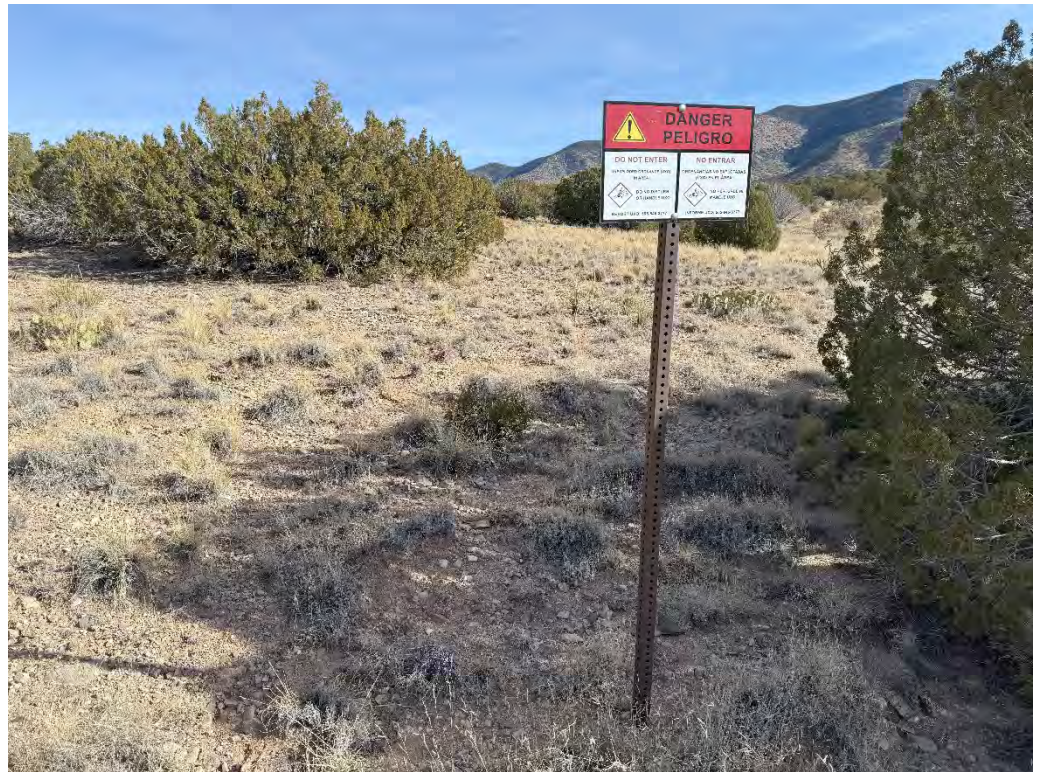
Site - ML125

Sign along southwestern boundary of MRS ML125. Photograph taken facing northeast.

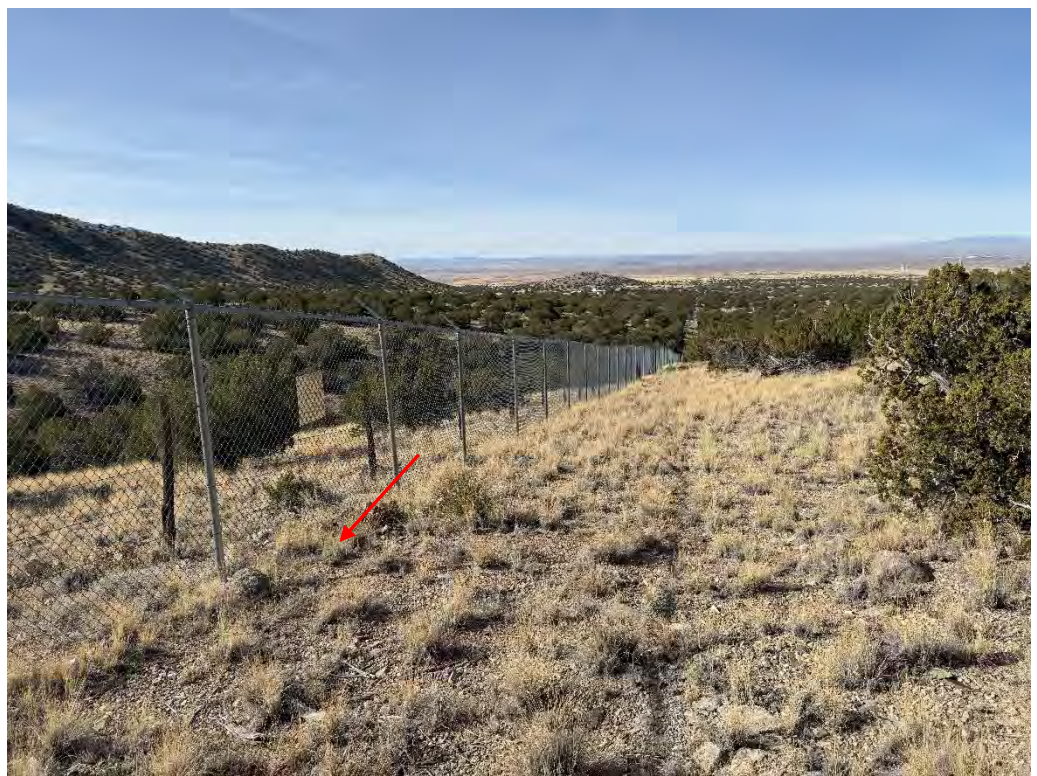
**Photograph No. 2**

Southern MRS ML125 boundary fence running along the left side of the photo. Photograph taken facing west.

The red arrow is showing a "USAF Installation" sign.

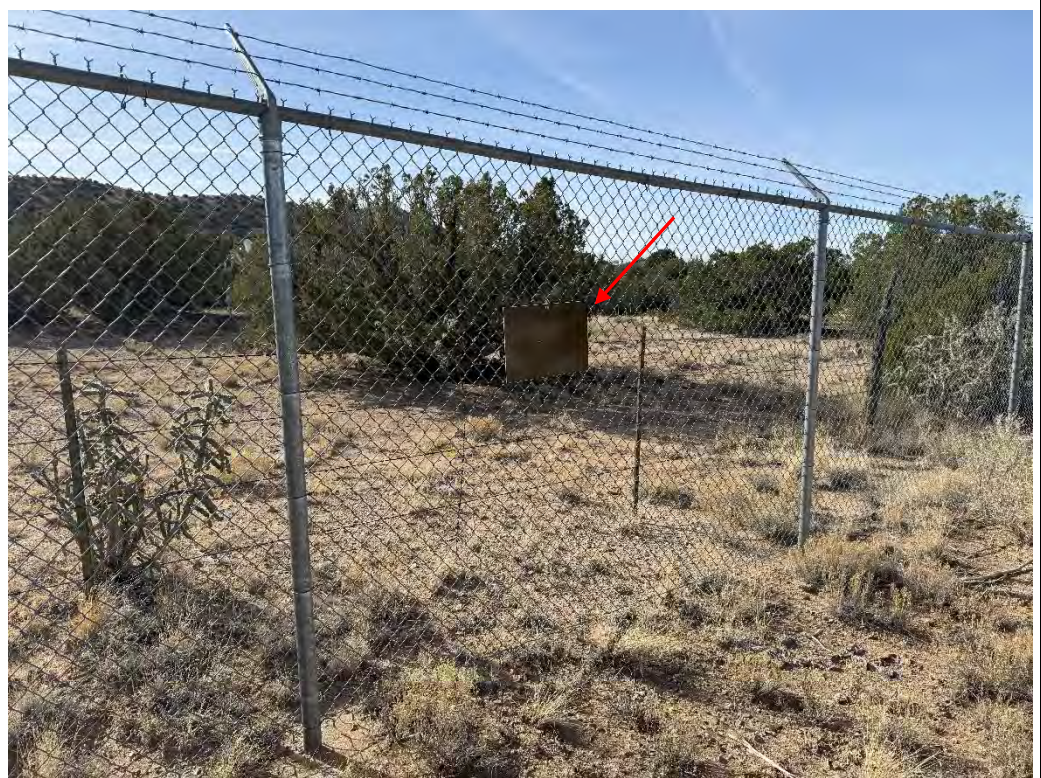
**Photograph No. 3**

Backside of sign along southern boundary of MRS ML125 boundary. Photograph taken facing south.

The red arrow is showing a "Danger UXO" sign.

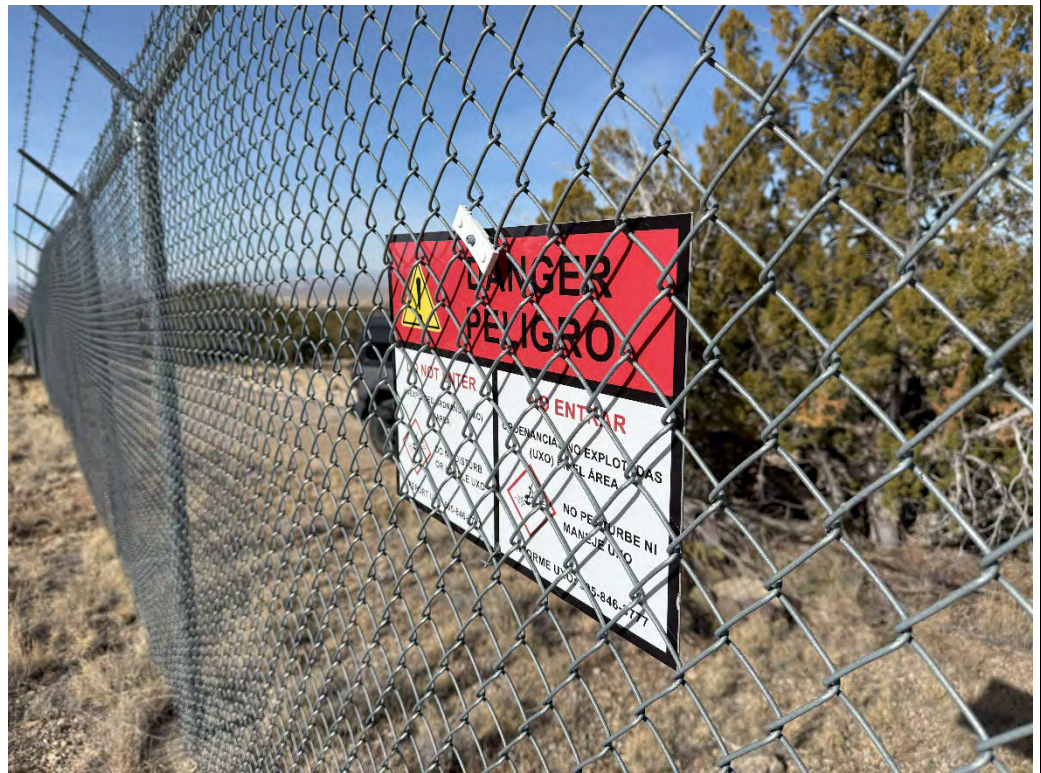
**Photograph No. 4**

Front side of sign (typical "Danger UXO" signage) marking southern boundary of MRS ML125. Photograph taken facing north.

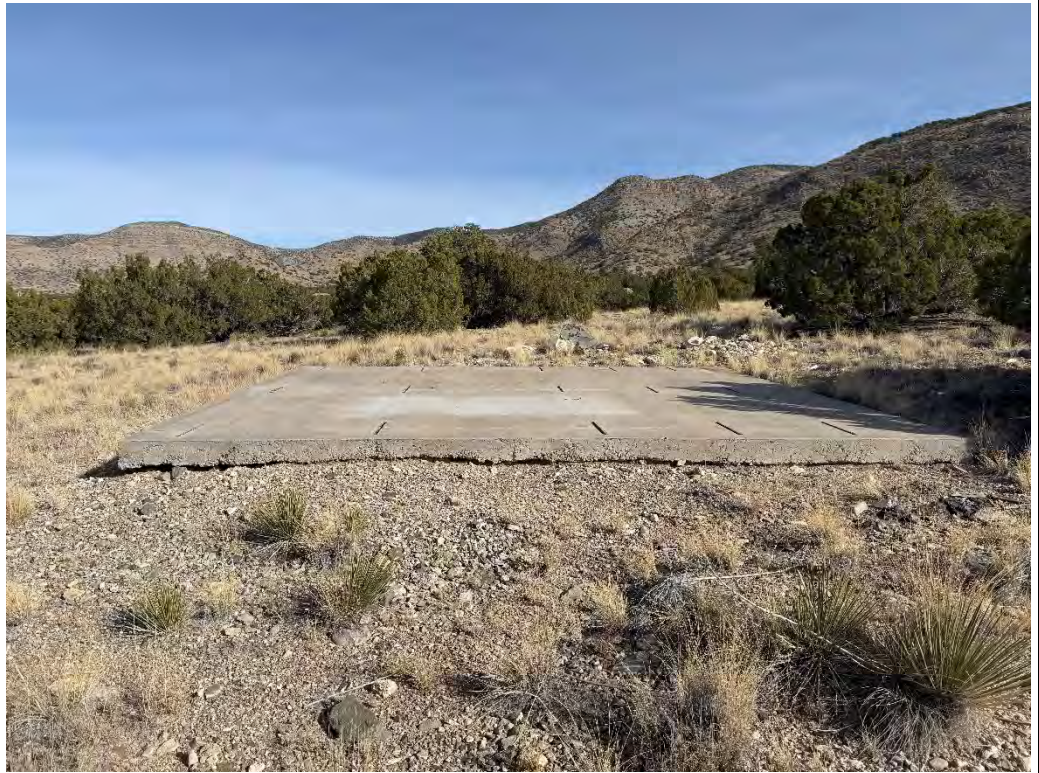
**Photograph No. 5****Description:**

Concrete slab located within  
MRS ML125.

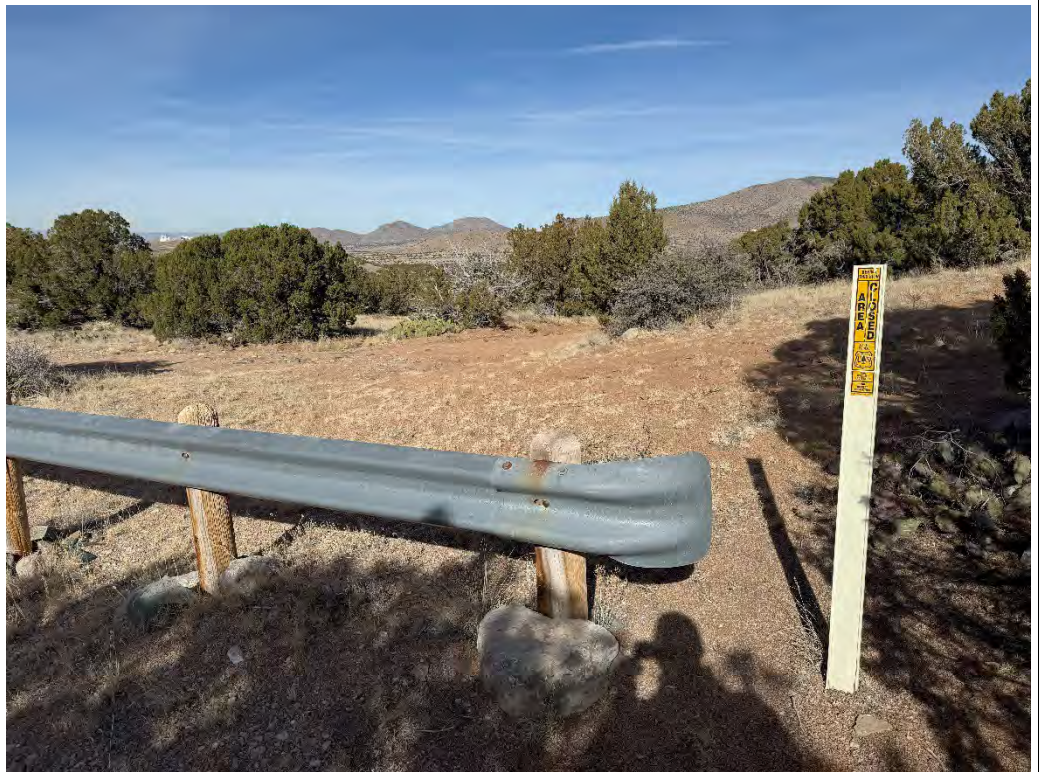
**Photograph No. 6****Description:**

Marker and barricade in place  
by the United States Forest  
Service for wildlife and  
habitat protection within MRS  
ML125.

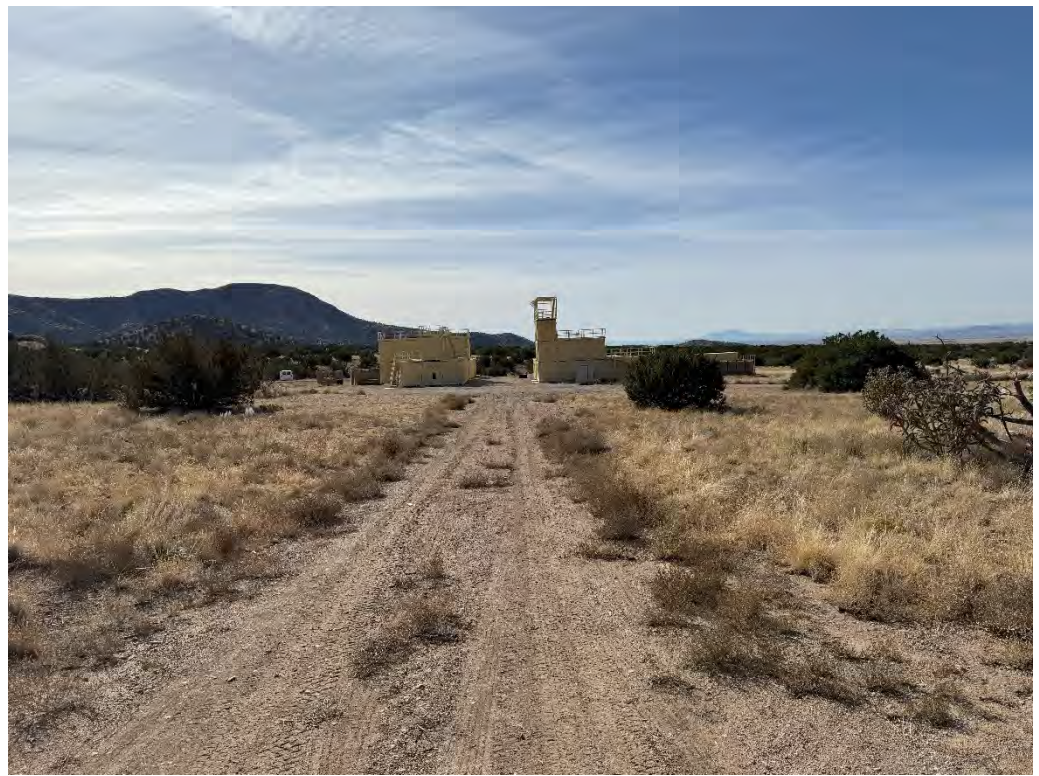
**Photograph No. 7**

Training structure located within MRS ML125.

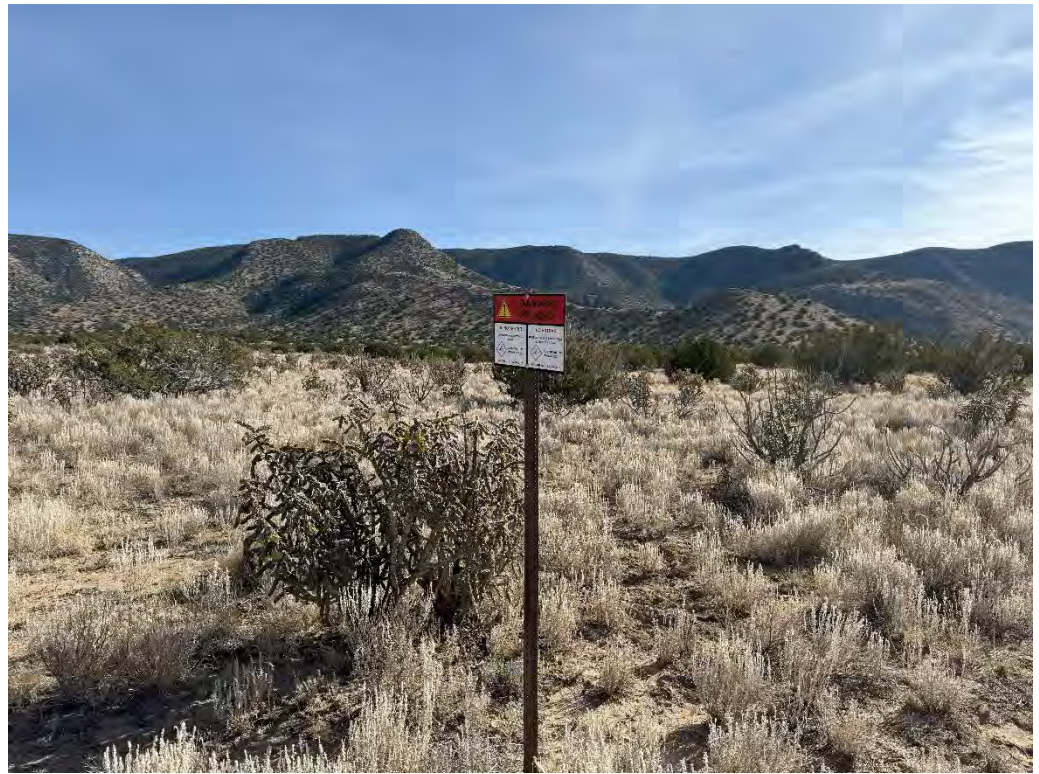
**Photograph No. 8**

Sign along northern boundary of MRS ML125. Photograph taken facing south.

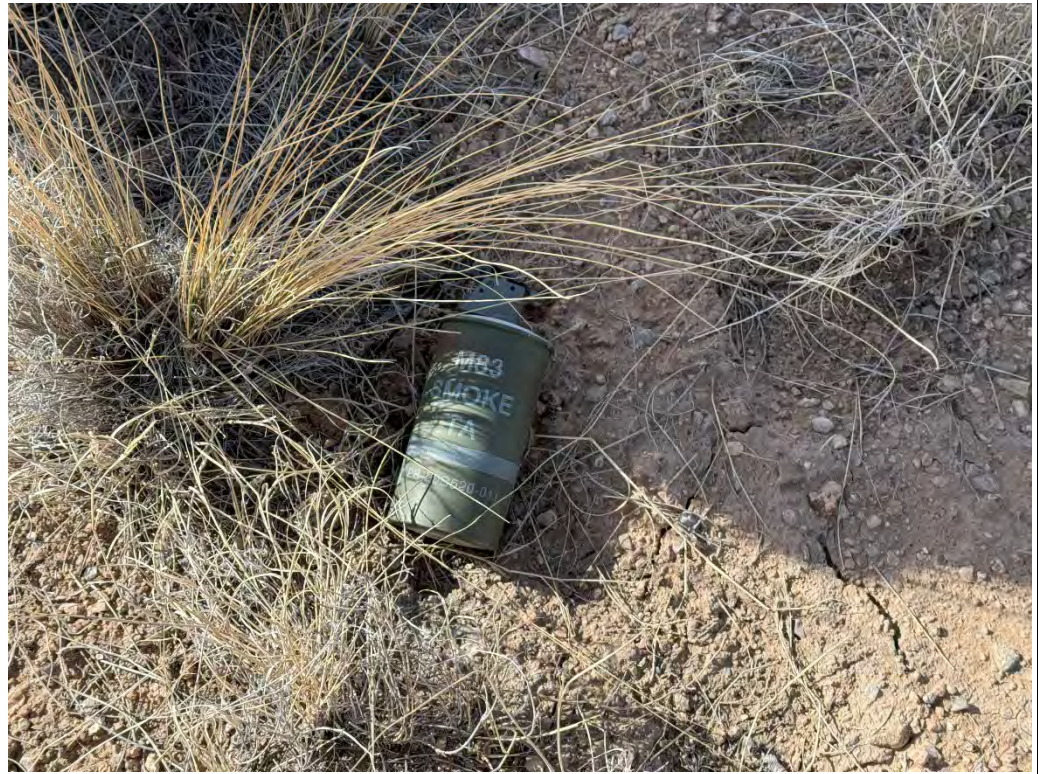
**Photograph No. 9**

M83 Smoke TA located within MRS ML125. Dozens of M83s were sighted during the inspection.

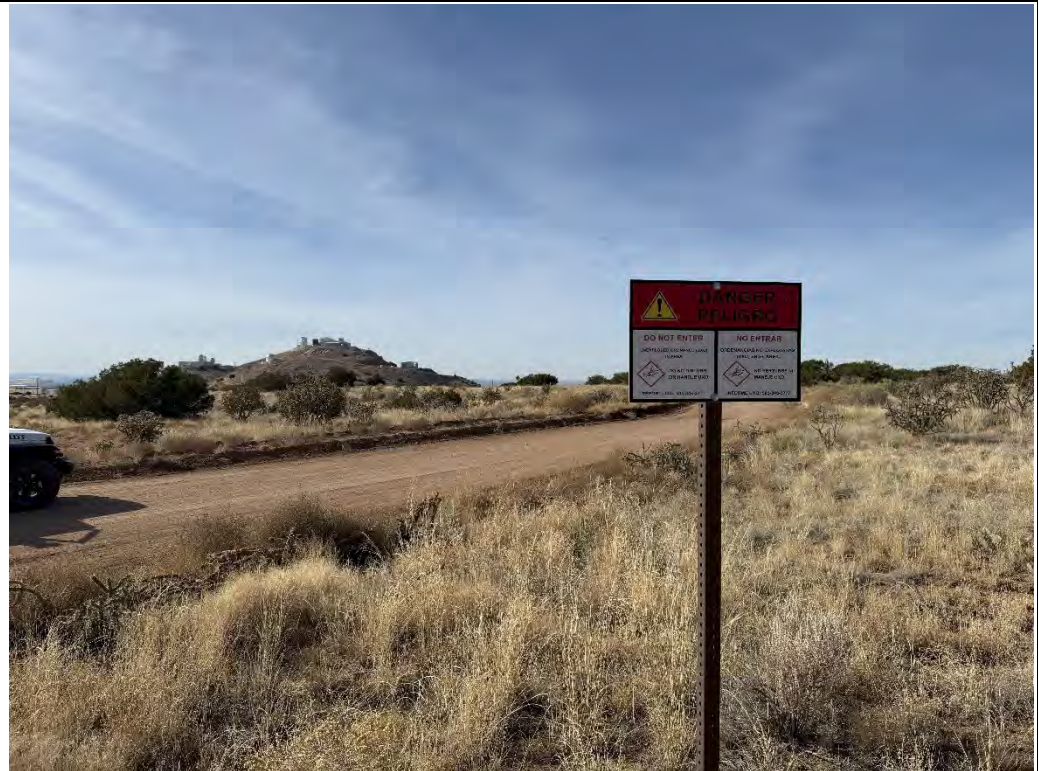
**Photograph No. 10**

Sign along northern edge of MRS ML125. Photograph taken facing west.

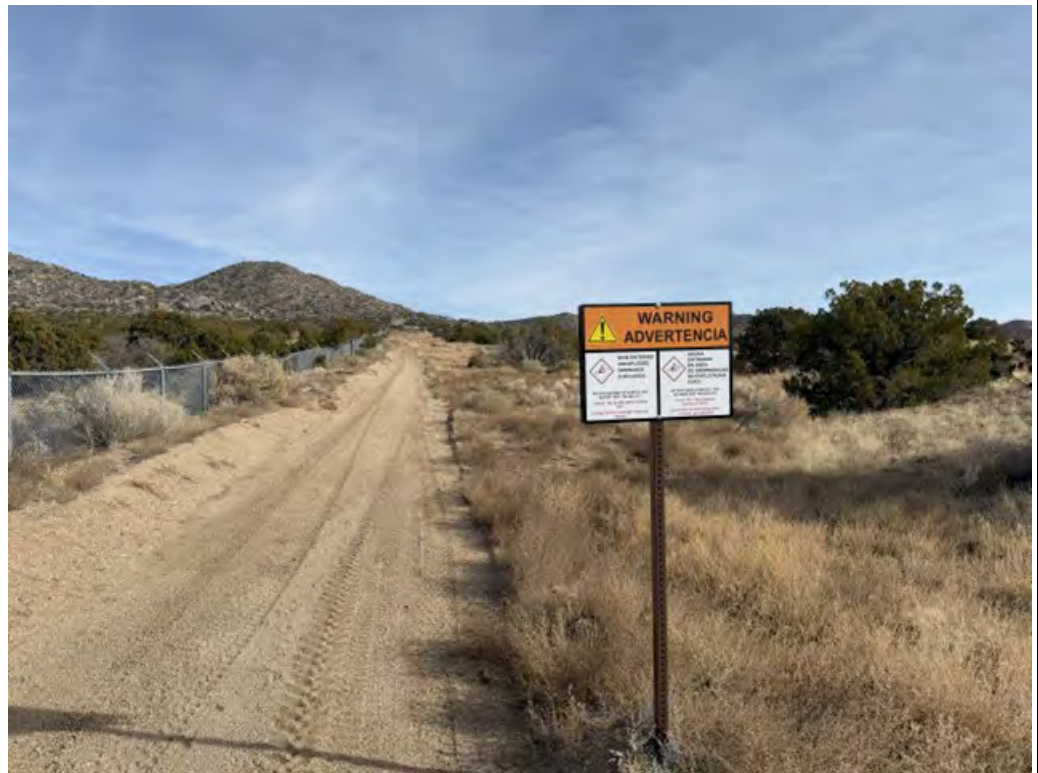
**Photograph No. 11****Description:**

Sign along western edge of MRS PT123, alerting reader they are entering UXO area. Fence in photo runs along northern boundary of the MRS. Photo taken facing east.

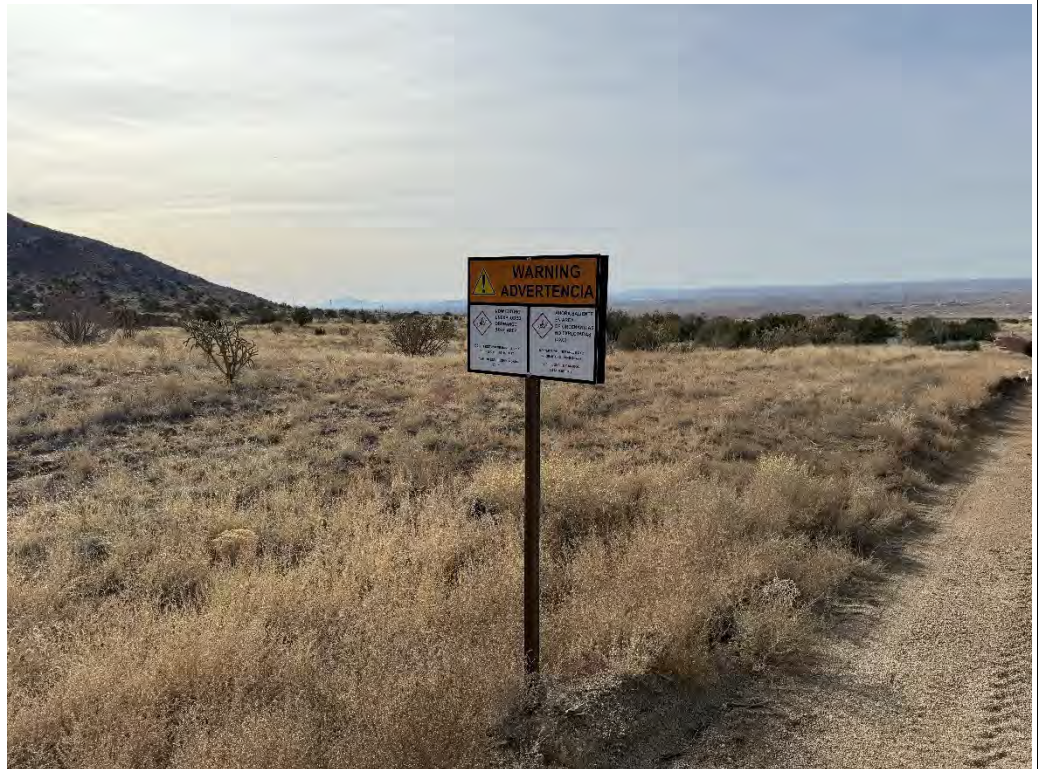
**Photograph No. 12****Description:**

Backside of sign from photograph number 11, alerting reader they are exiting the UXO area (MRS PT123).

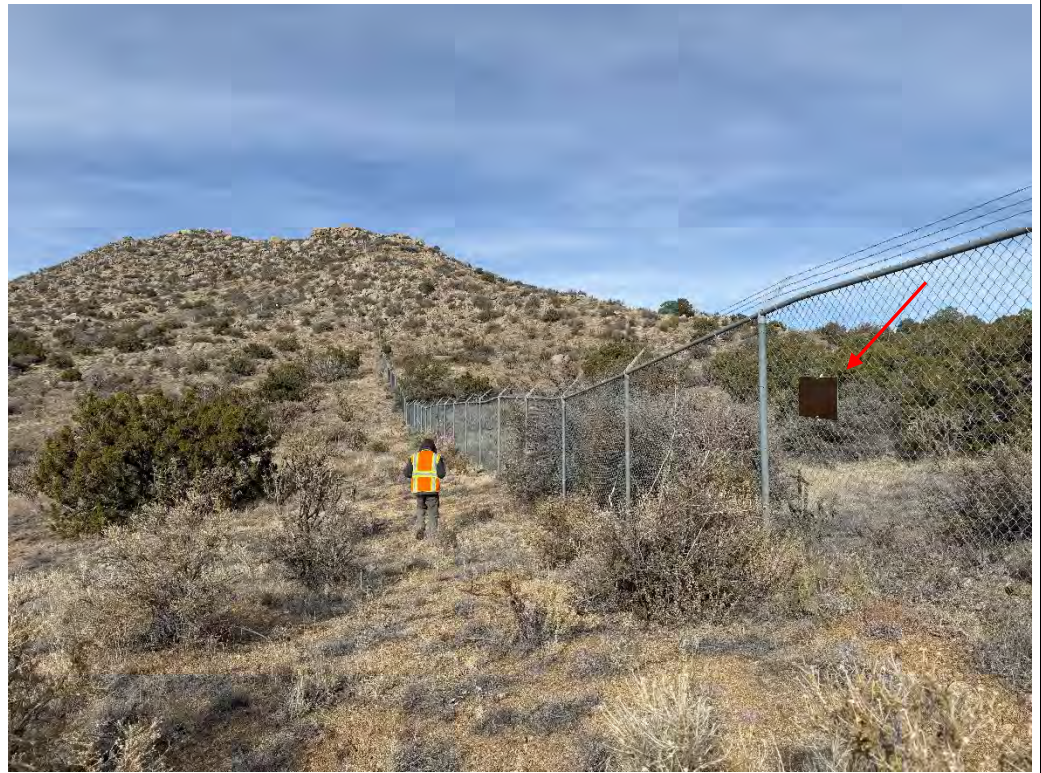
**Photograph No. 13**

Walking along eastern boundary fence of MRS PT123 to verify signs are in place. Photograph taken facing north.

The red arrow is showing a “Danger UXO” sign.

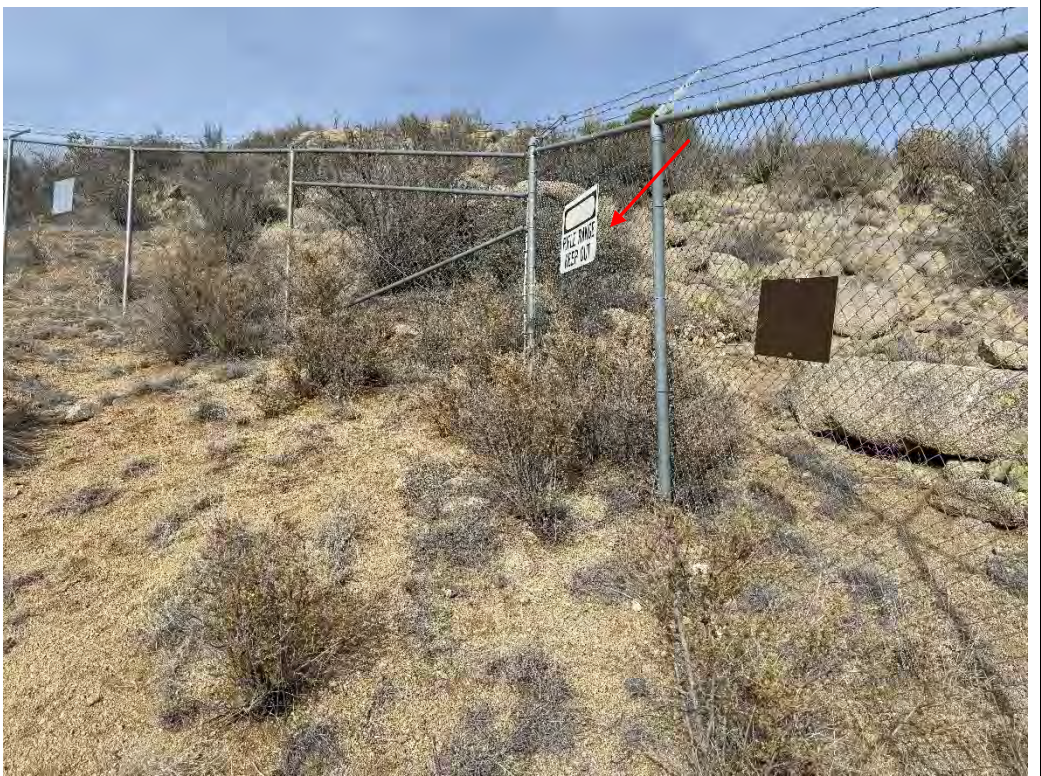
**Photograph No. 14**

Northeast corner of MRS PT123.

The red arrow is showing a “Rifle Range – Keep Out” sign.

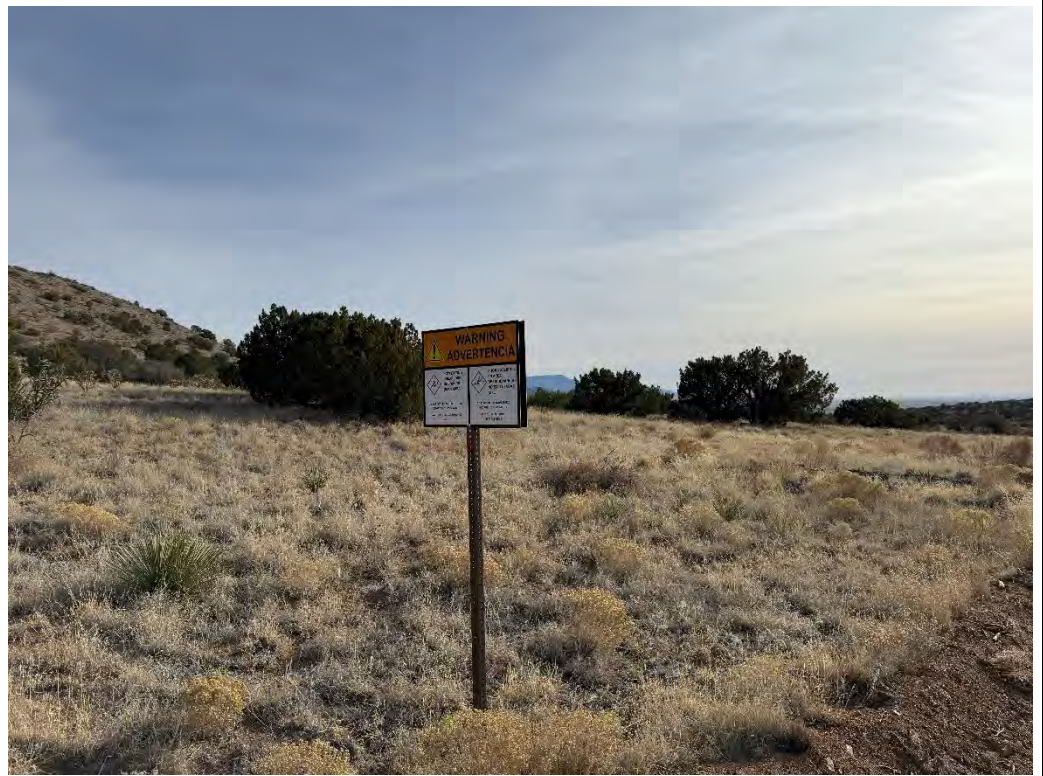
**Photograph No. 15**

Sign along western boundary of MRS ML125 notifying reader they are leaving UXO area. Photograph taken facing southwest.

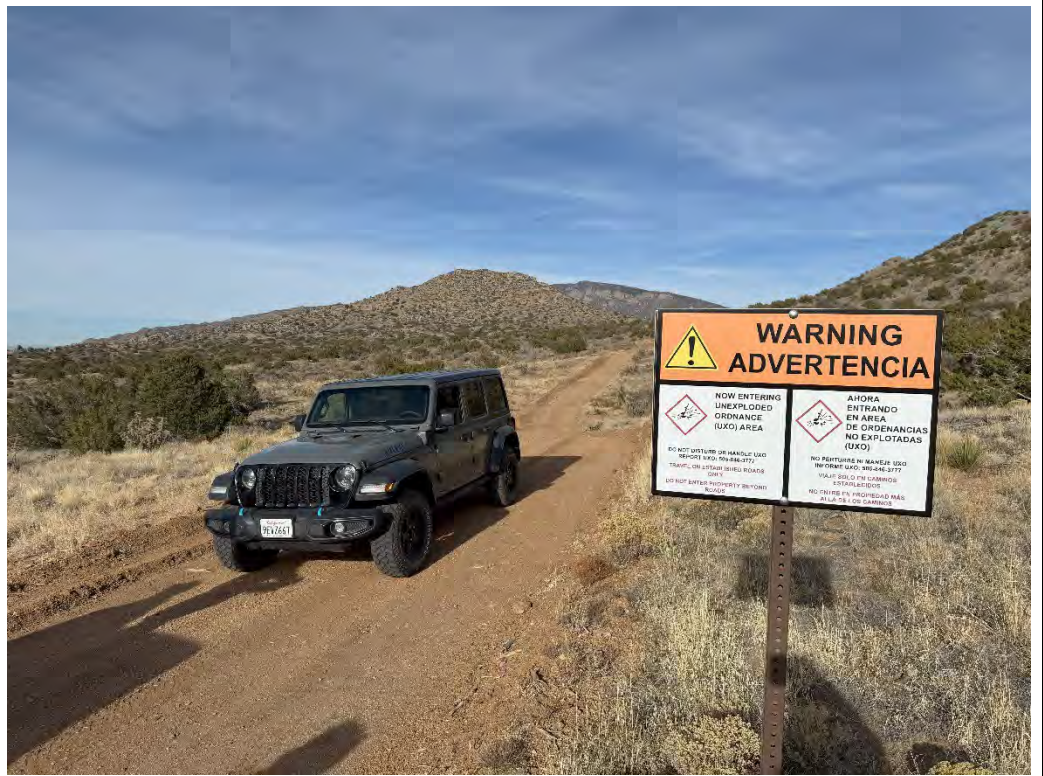
**Photograph No. 16**

Sign along western boundary of MRS PT123. Photograph taken facing east.

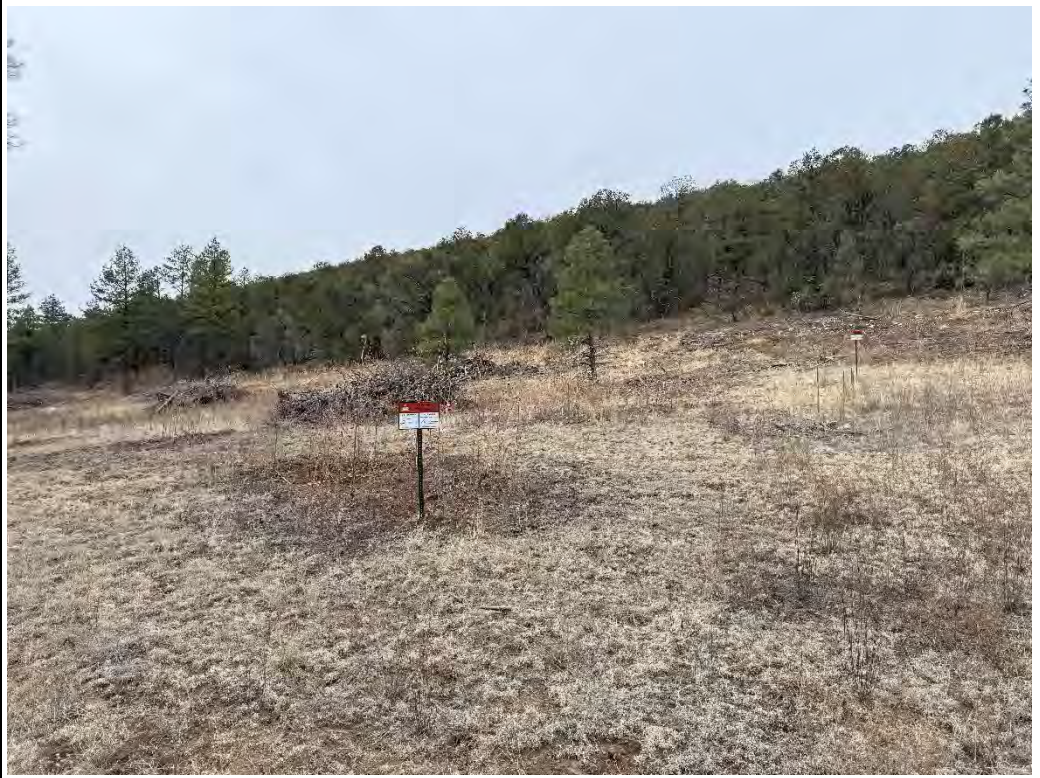
**Photograph No. 17****Description:**

Signs at the northeast corner of the boundary of MRS AL120. Photograph taken facing southwest.

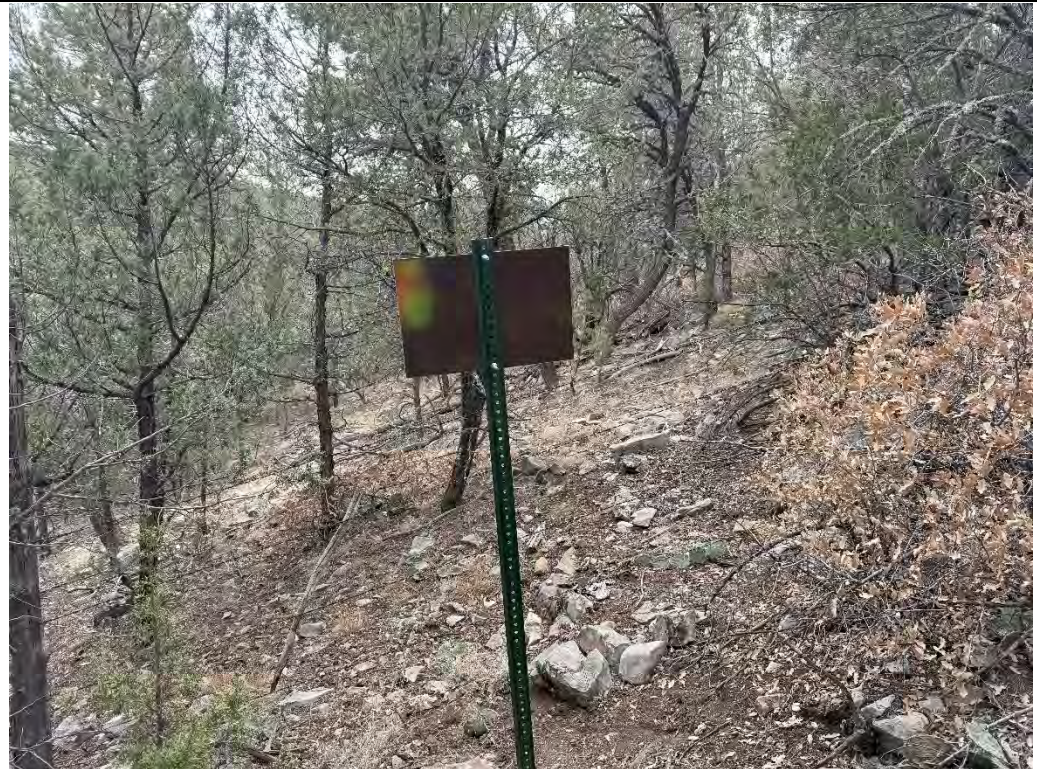
**Photograph No. 18****Description:**

Backside of a sign along the southern boundary of MRS AL120. Photograph taken facing south.

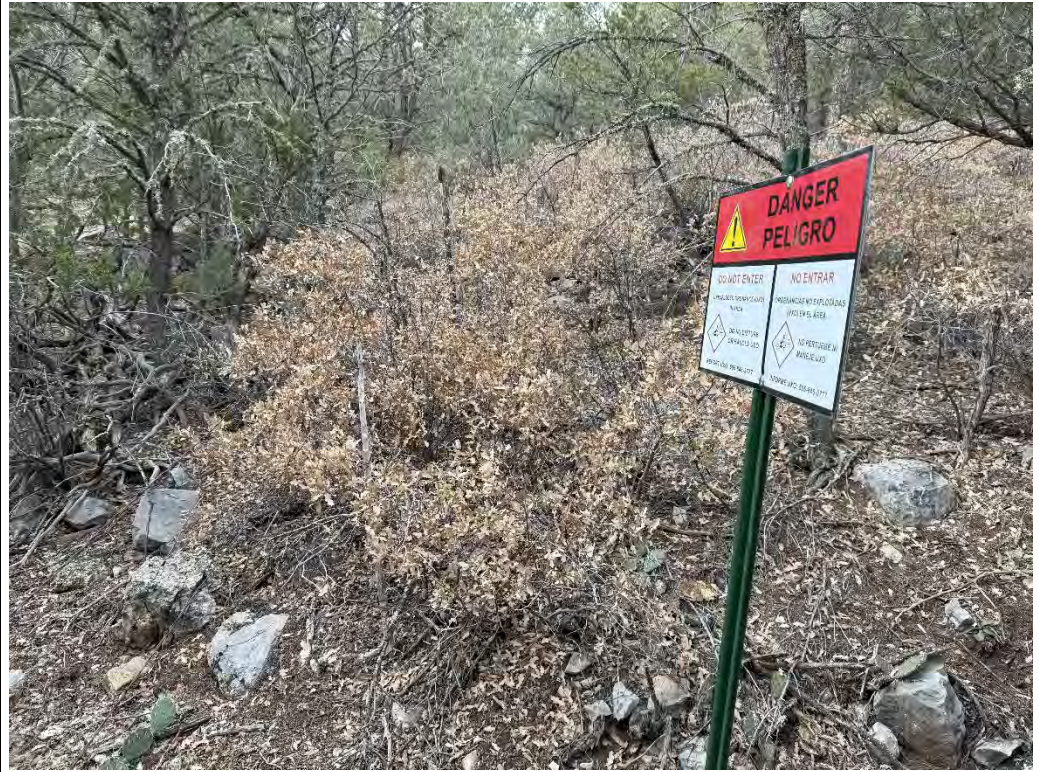
**Photograph No. 19****Description:**

Front side of sign along southern boundary of MRS AL120. Photograph taken facing northwest.

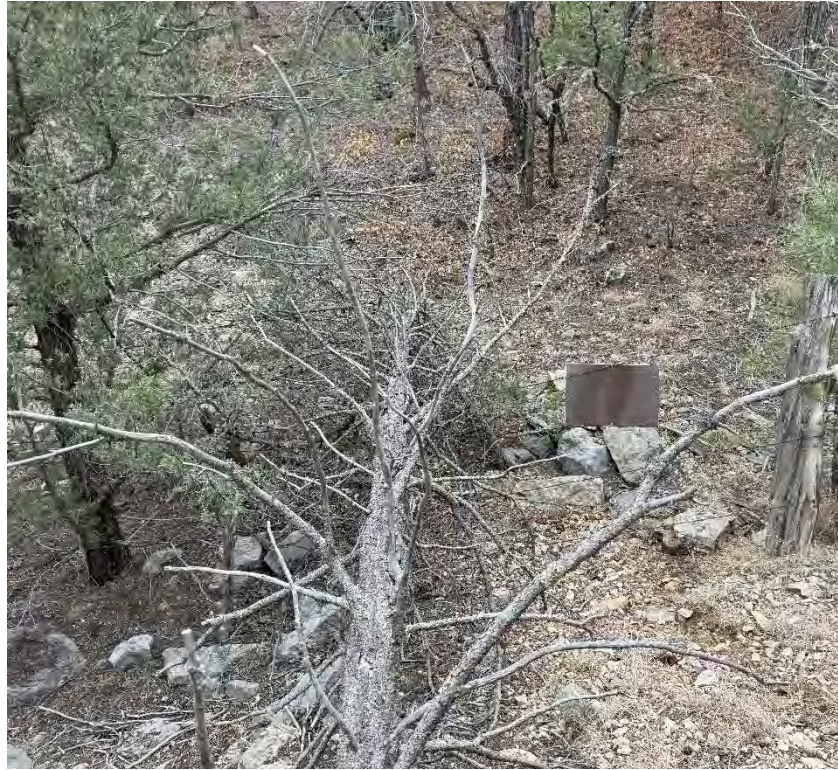
**Photograph No. 20****Description:**

Backside of fence along the southern boundary of MRS AL120. Photograph taken facing south.

1. Continue to perform annual LUC inspections.
2. The recommendation to upgrade security infrastructure to install a new chain-link fence along the southern boundary of AL120 / replace the existing degraded fencing. This action will strengthen site security and prevent unauthorized access.

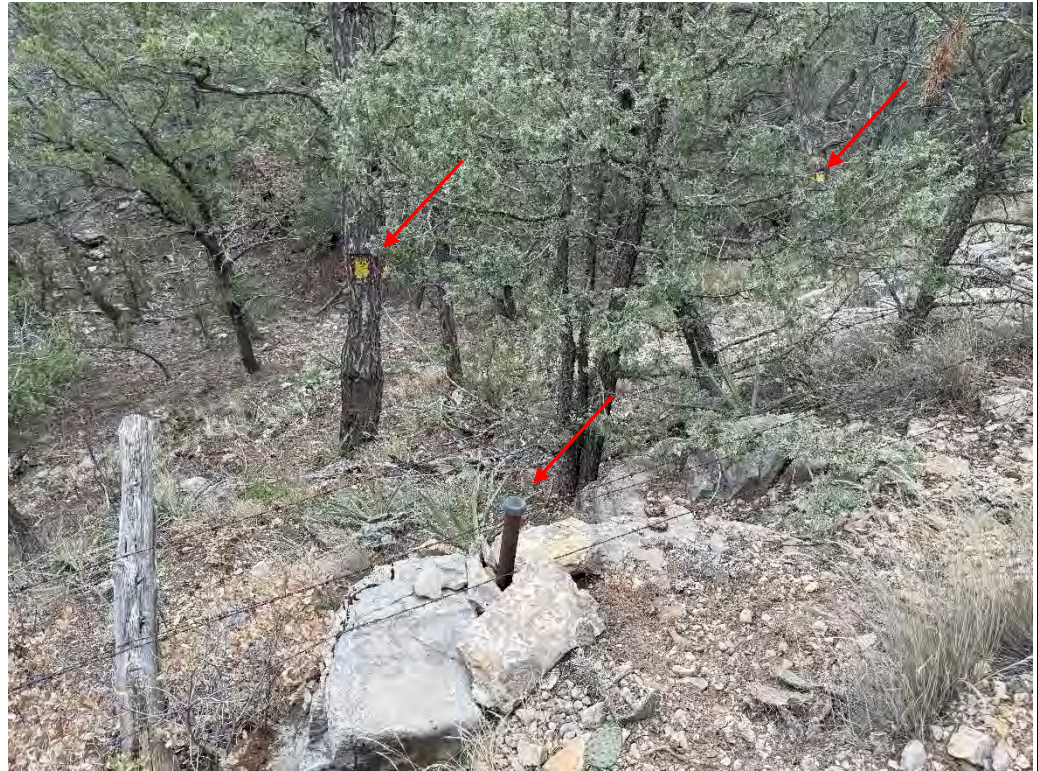
**Photograph No. 21**

Bearing Tree marker located outside of the southern boundary of MRS AL120. Photograph taken facing south.

The top red arrows are showing Bearing Tree markers. The bottom red arrow is showing a survey marker.

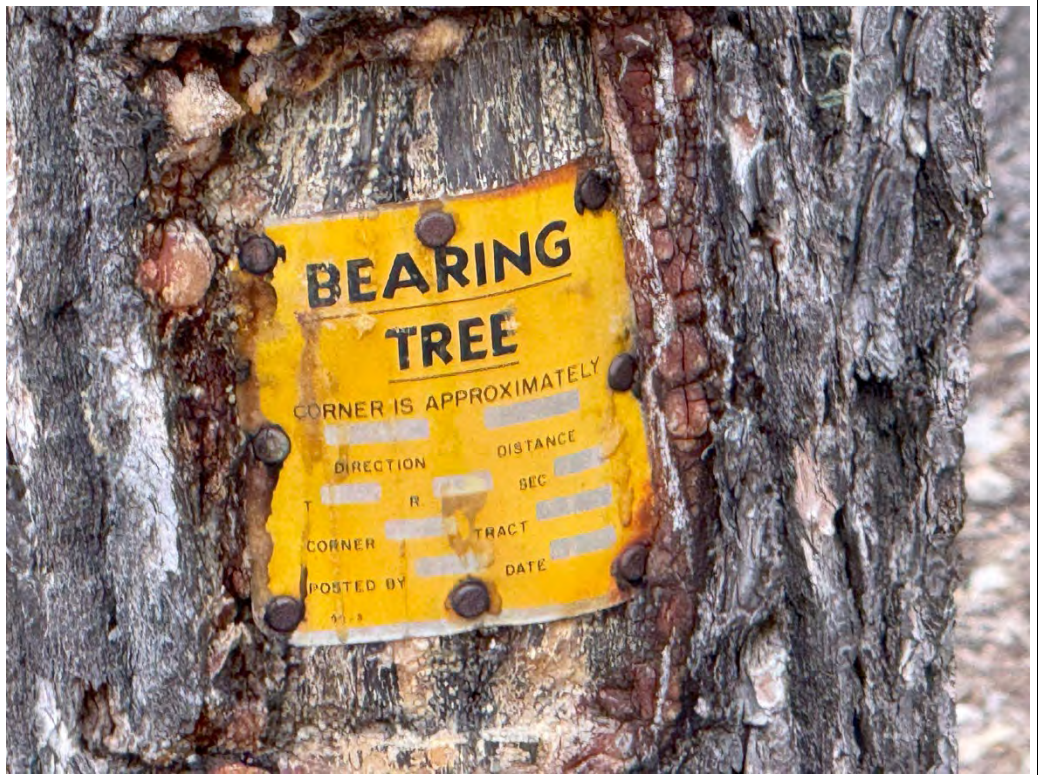
**Photograph No. 22**

Close up Bearing Tree marker.

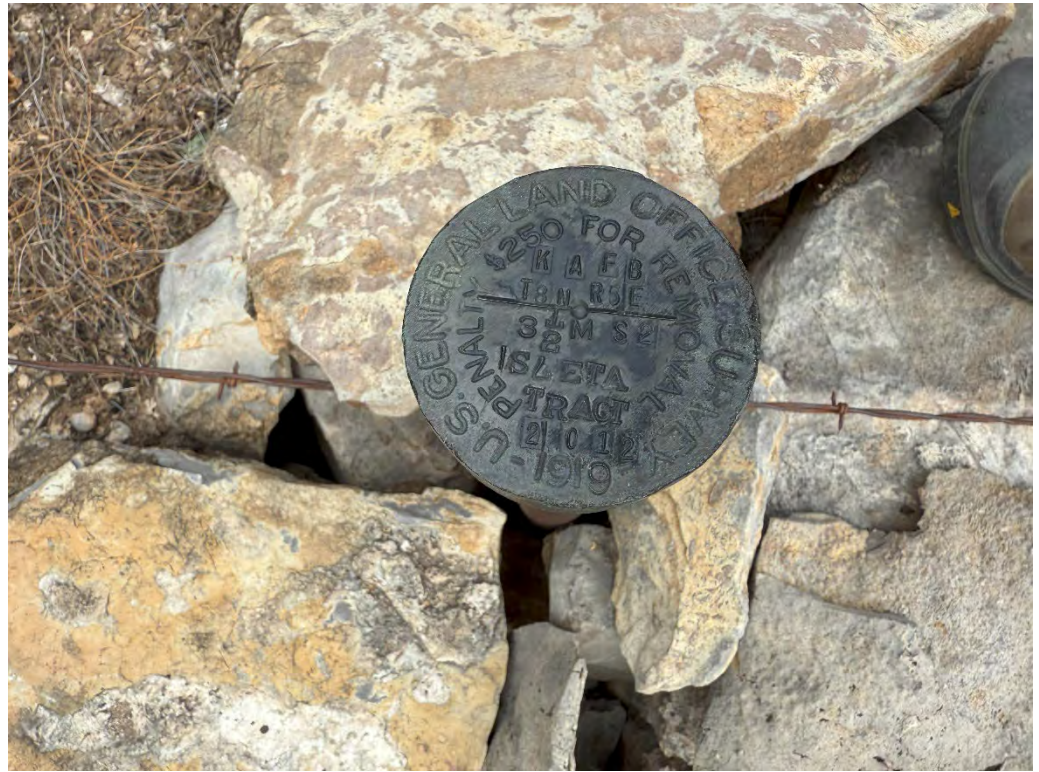
**Photograph No. 23****Description:**

Survey marker located along the southern boundary of MRS AL120.

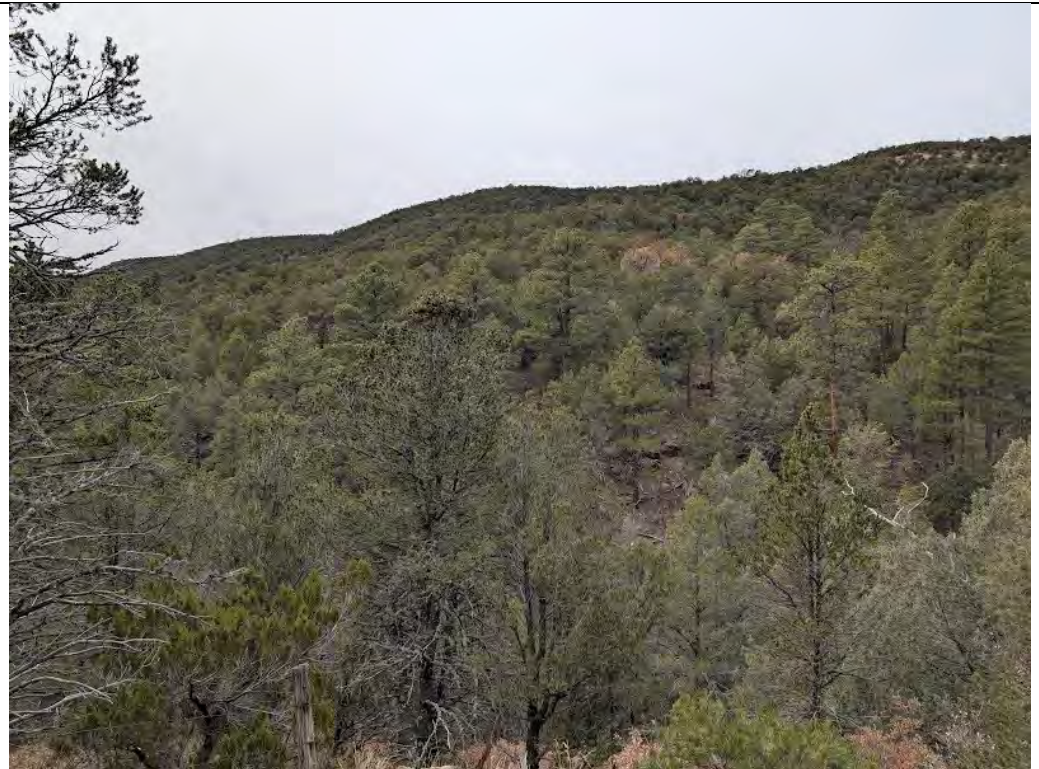
**Photograph No. 24****Description:**

Photograph taken facing southwest. Southern boundary fence of MRS AL120 runs along bottom left of photograph.
