Kirtland Air Force Base—Landfill 002 (SWMU 6-2)

Monitoring and Inspections

Kirtland Air Force Base—Landfill 001 (SMWU 6-1)

Kirtland Air Force Base—Site WP-026 (SWMU WP-026)

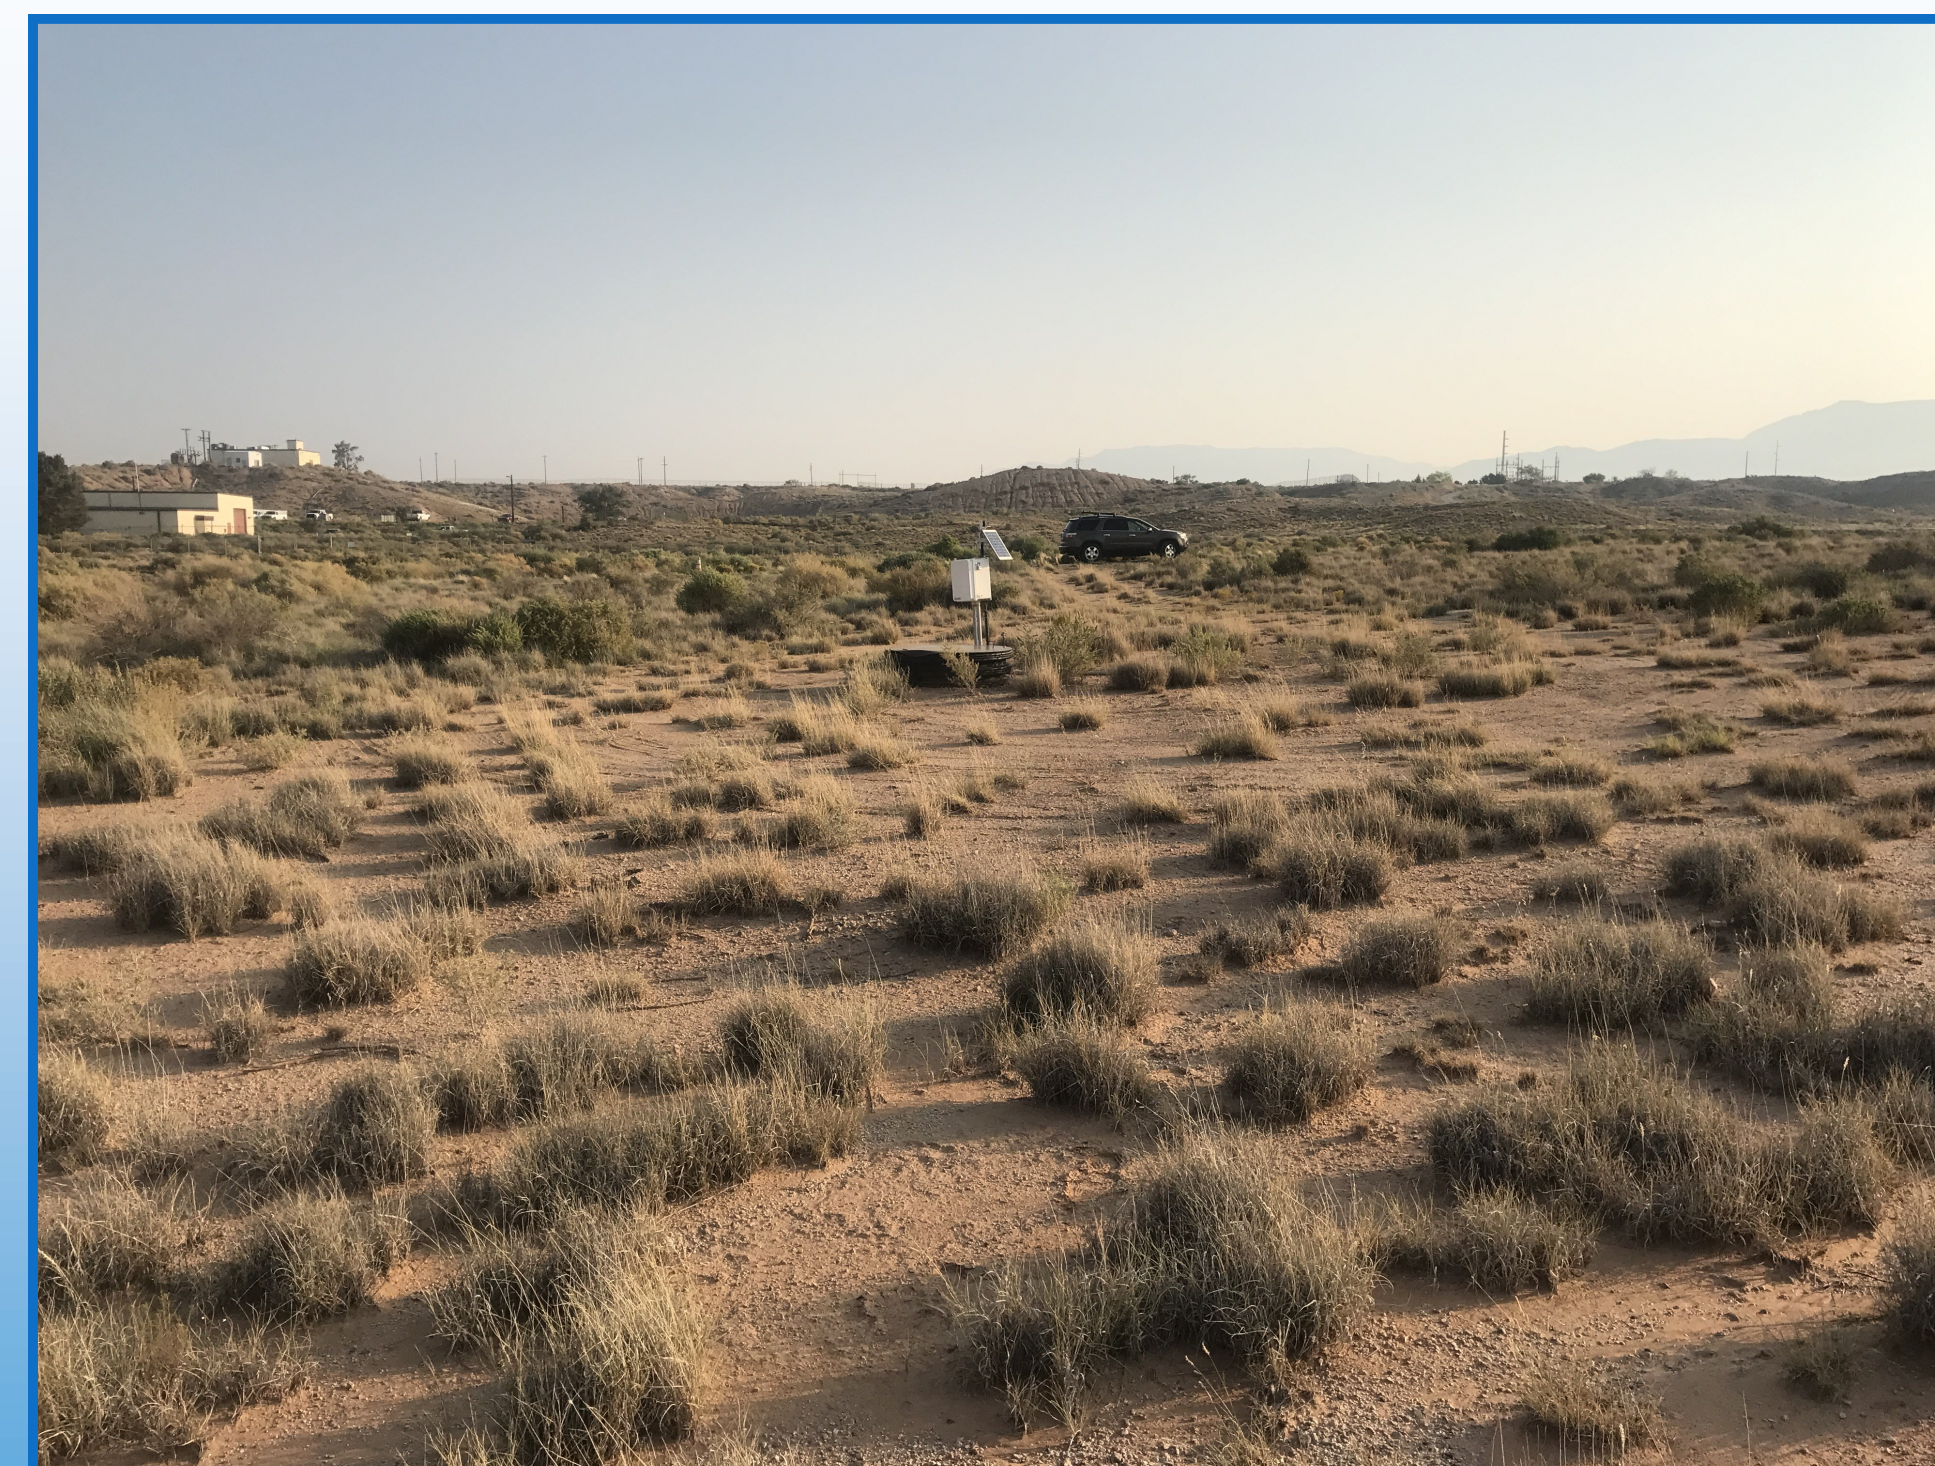
Evapotranspiration (ET) Cover

- Selected as preferred alternative in Corrective Measures Study
- ET cover is 32 acres in area
- ET cover system includes 36" ET cover overlaying a 6" compacted subgrade layer
- Soils for ET cover specified as silty sand, silty-clayey sand, or silty clay, with 99% passing a 1 inch sieve
- Design objective of ET cover was to achieve target percolation rate of 2.5 millimeters per year or less

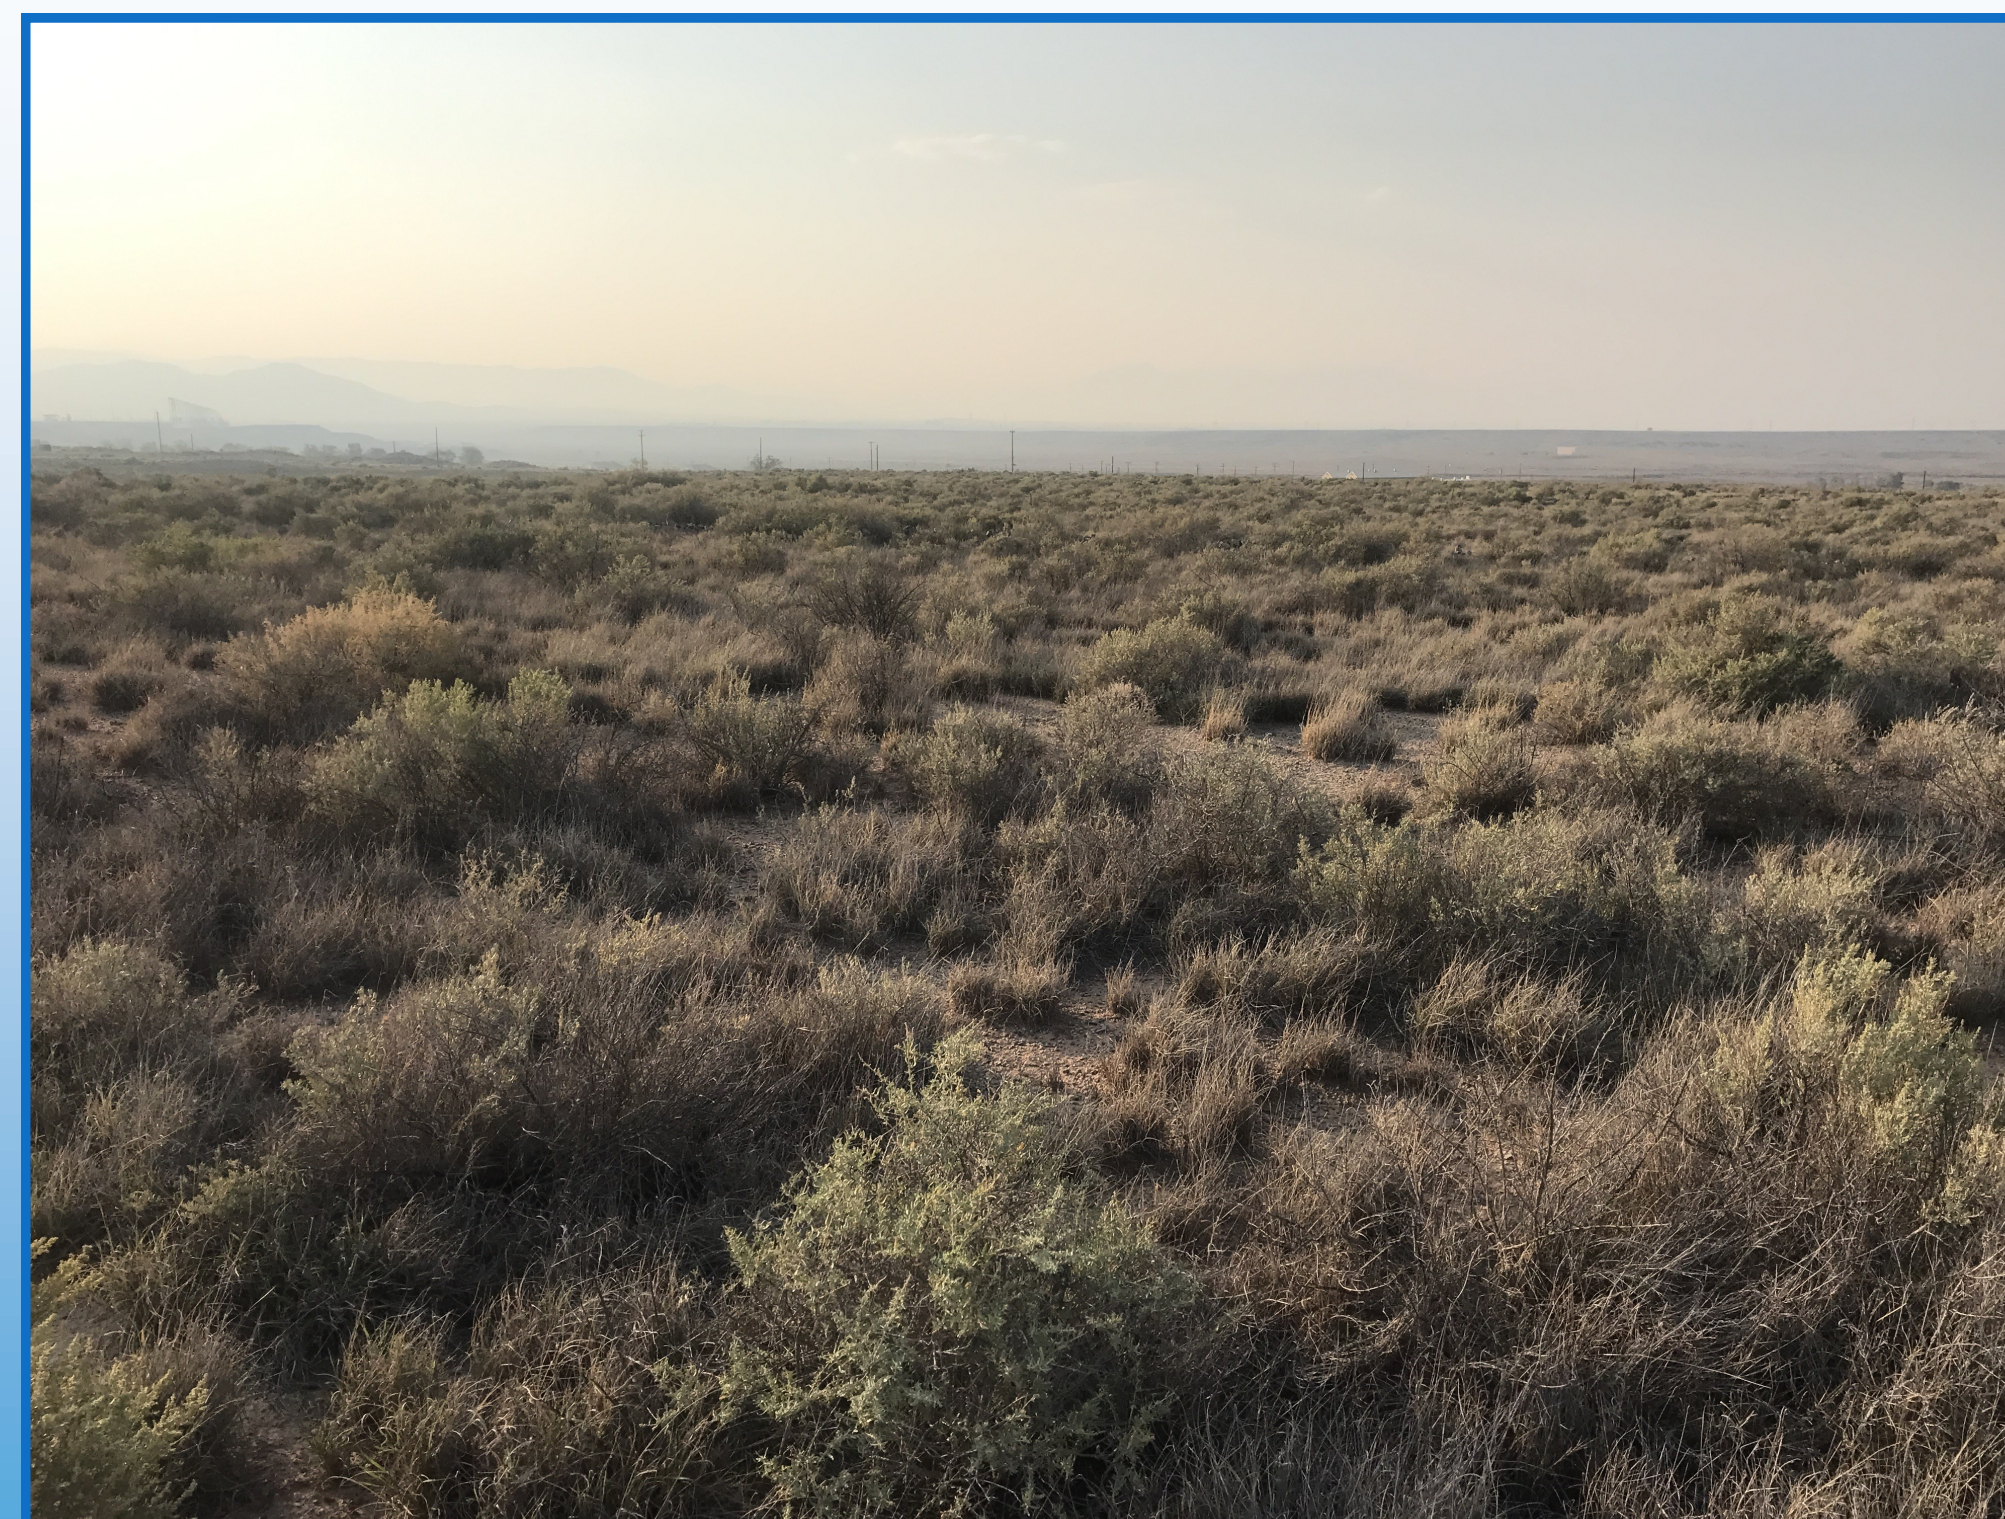
Evapotranspiration (ET) Cover

- Selected as preferred alternative in Corrective Measures Study
- ET cover is 49 acres in area
- ET cover system includes 36" ET cover overlaying a 6" compacted subgrade layer
- Soils for ET cover specified as silty sand, silty-clayey sand, or silty clay, with 99% passing a 1 inch sieve
- Design objective of ET cover was to achieve target percolation rate of 2.5 millimeters per year or less

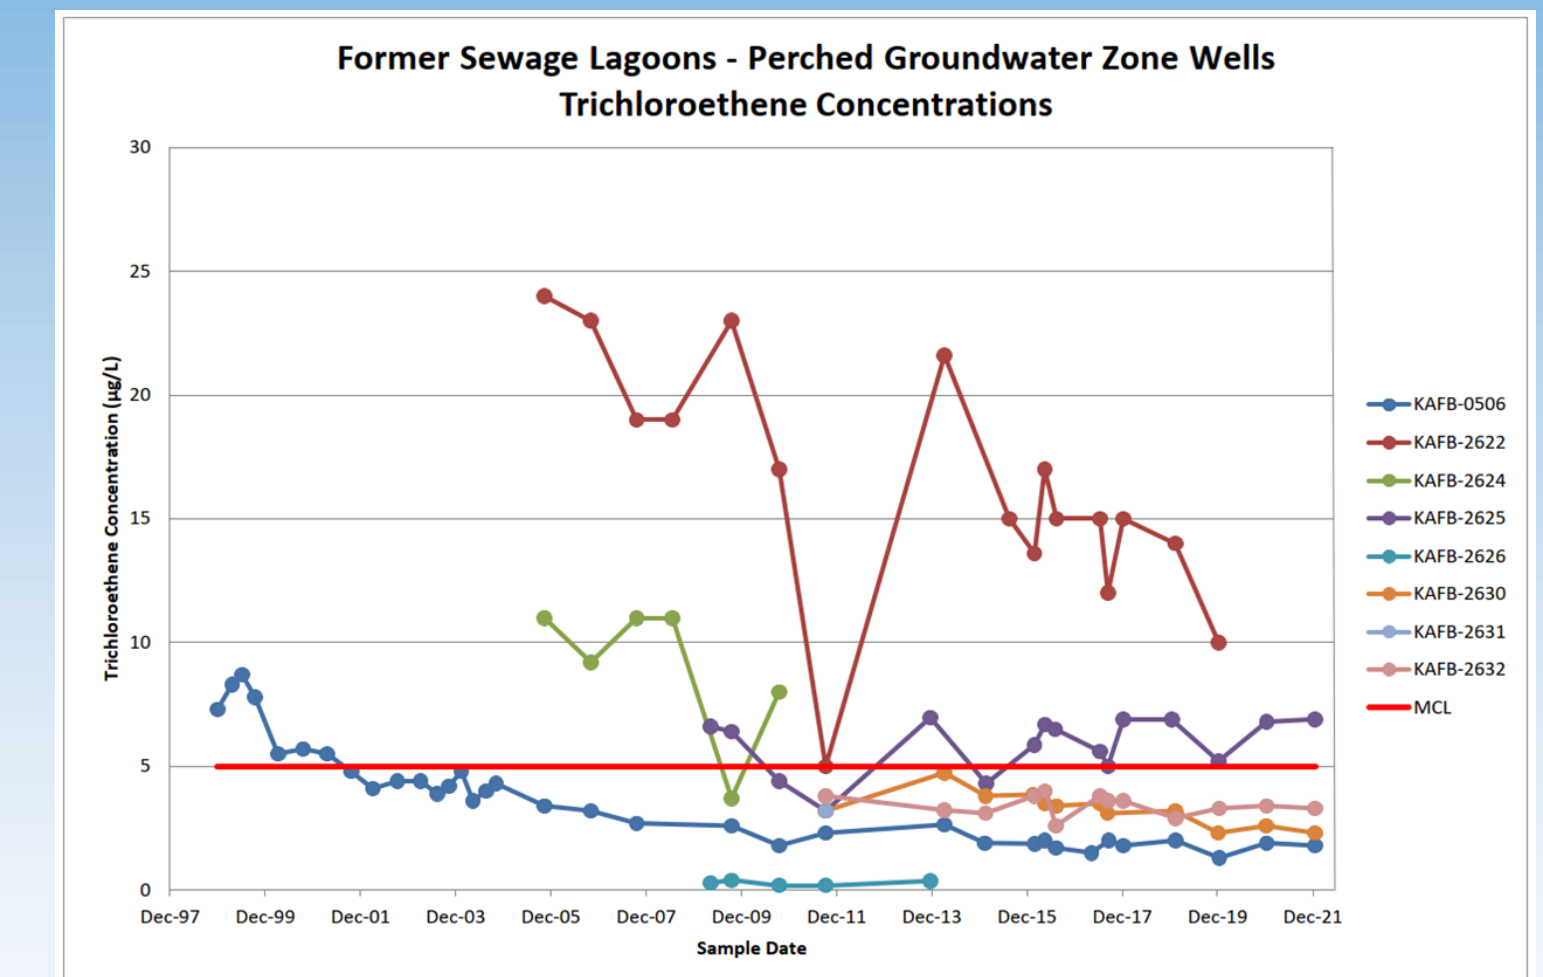
Perched Groundwater Zone TCE Trends - Dec 2021

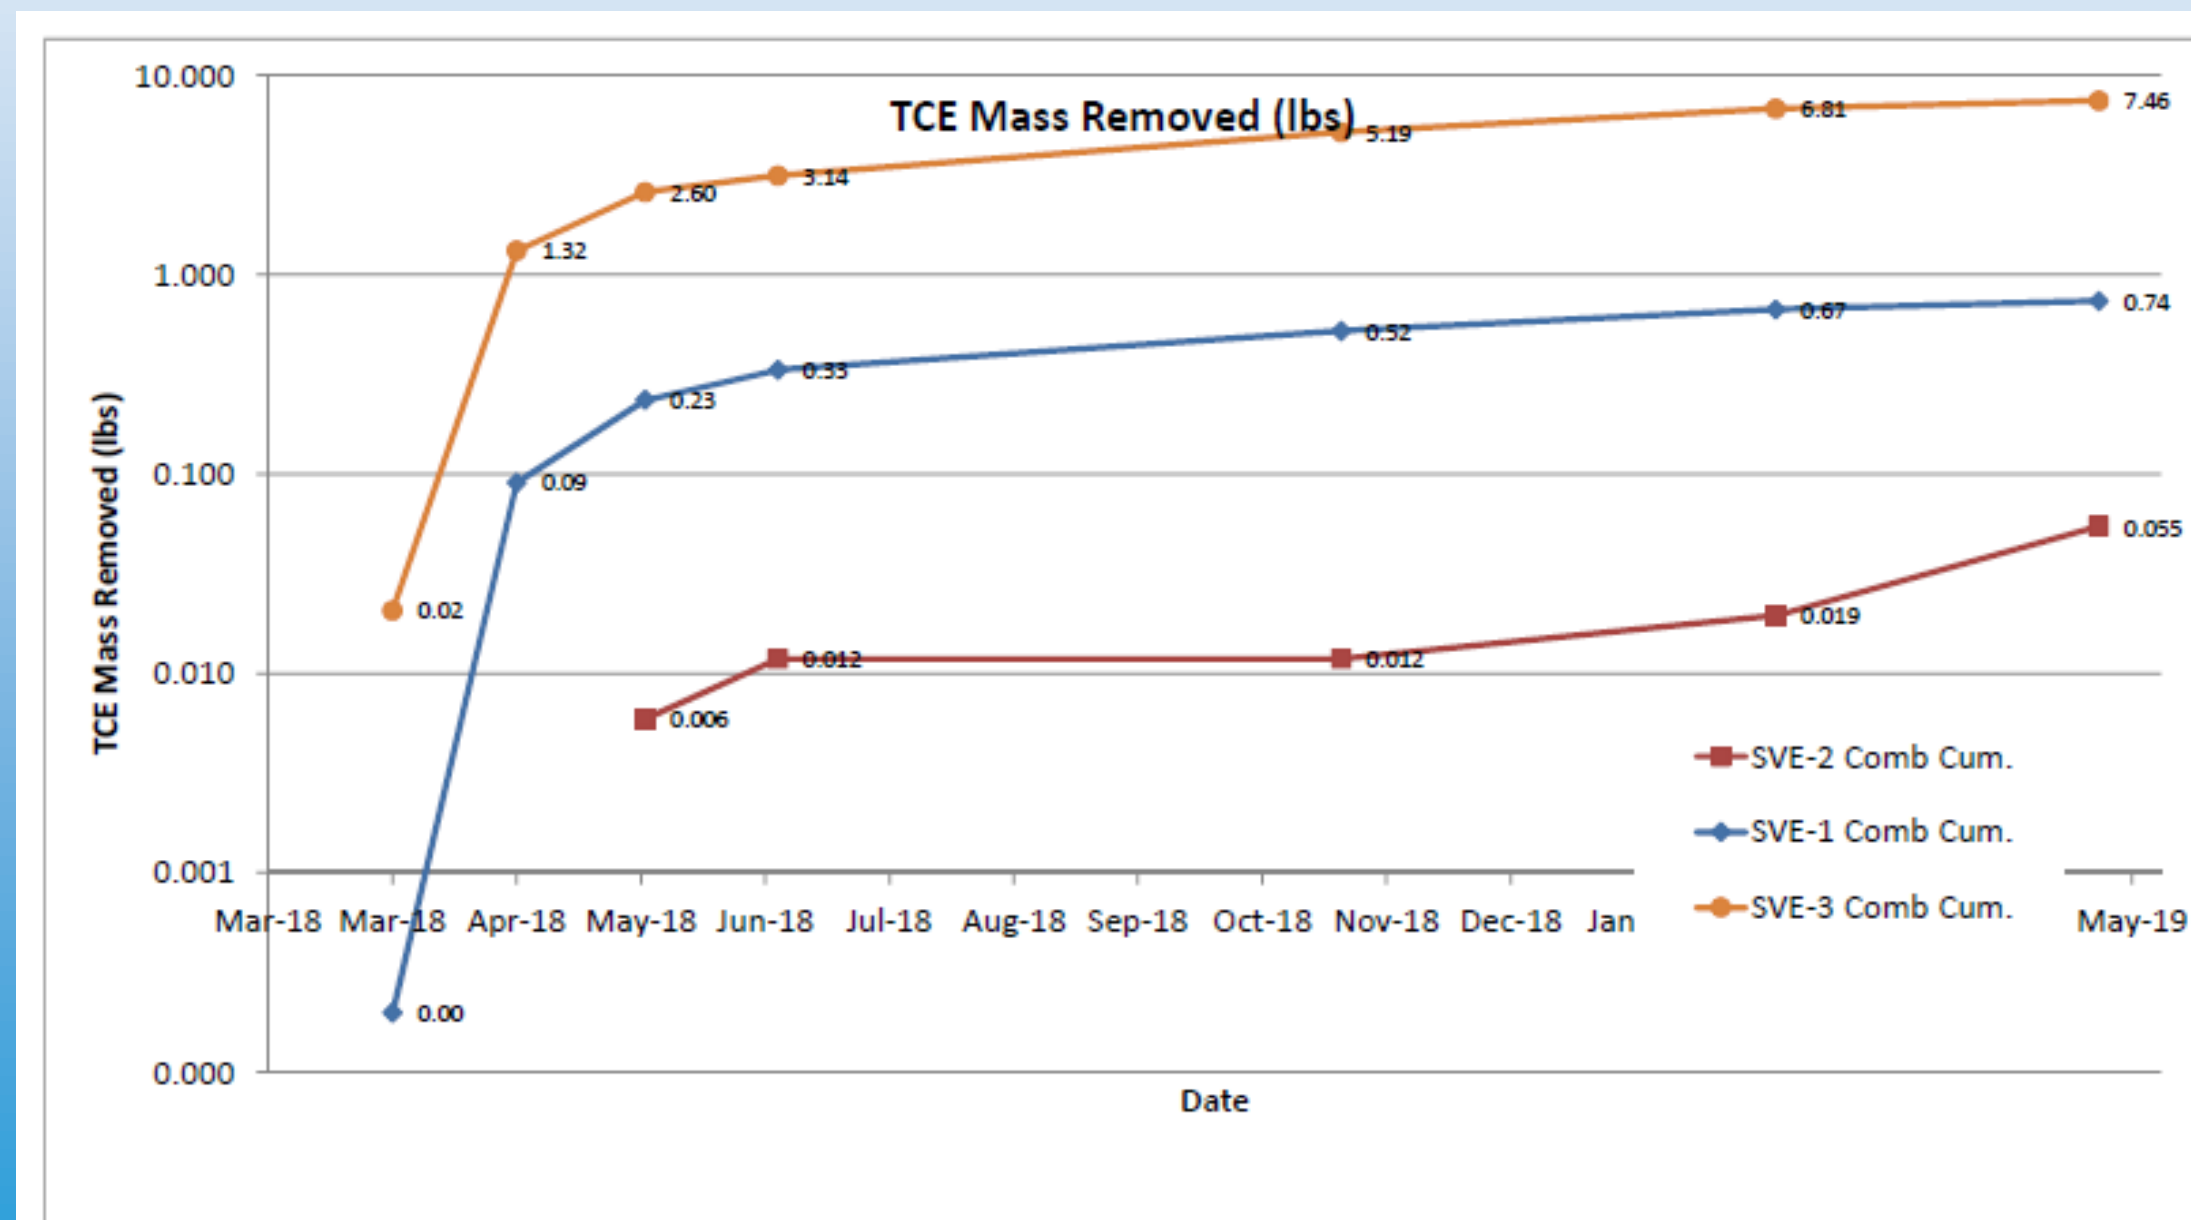
ST-070E TCE Mass Removed Since 2018 Restart

- Mass Removal Since SVE Upgrade Restart (March 2018 through May 2019)
 - TPH (gasoline range) - 12,918 lbs
 - Tetrachloroethylene (TCE) - 8.3 lbs
 - Trichloroethylene (PCE) - 4.2 lbs
