Kirtland Air Force Base—Site ST-070E

Kirtland Air Force Base—Site WP-026 (SWMU WP-026)

Kirtland Air Force Base—CG107 (WYO-4) Area of Concern

Kirtland Air Force Base—Landfill 001 (SMWU 6-1)

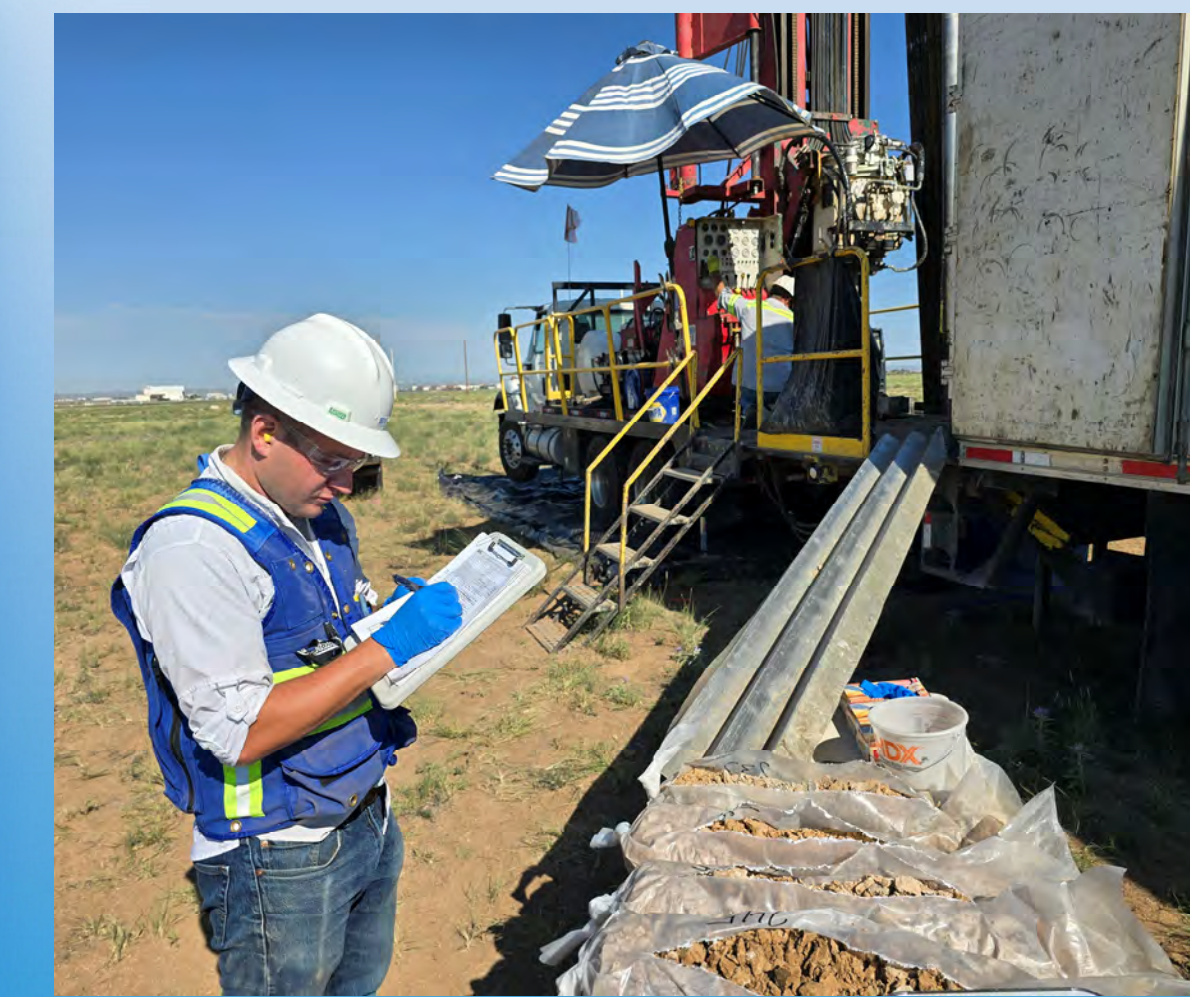
Installation of KAFB-WYO-5

- Three perched groundwater zone wells were installed:
 - KAFB-WYO-5 (replacement for dry well WYO-4)
 - KAFB-WYO-6 and KAFB-WYO-7 (downgradient of dry well WYO-4)
- Initial sampling and gauging were conducted in the perched groundwater zone.
- A RCRA Facility Investigation Report was developed to document monitoring well installation activities and the results of sampling and monitoring. This report was delivered to NMED on April 30, 2025.

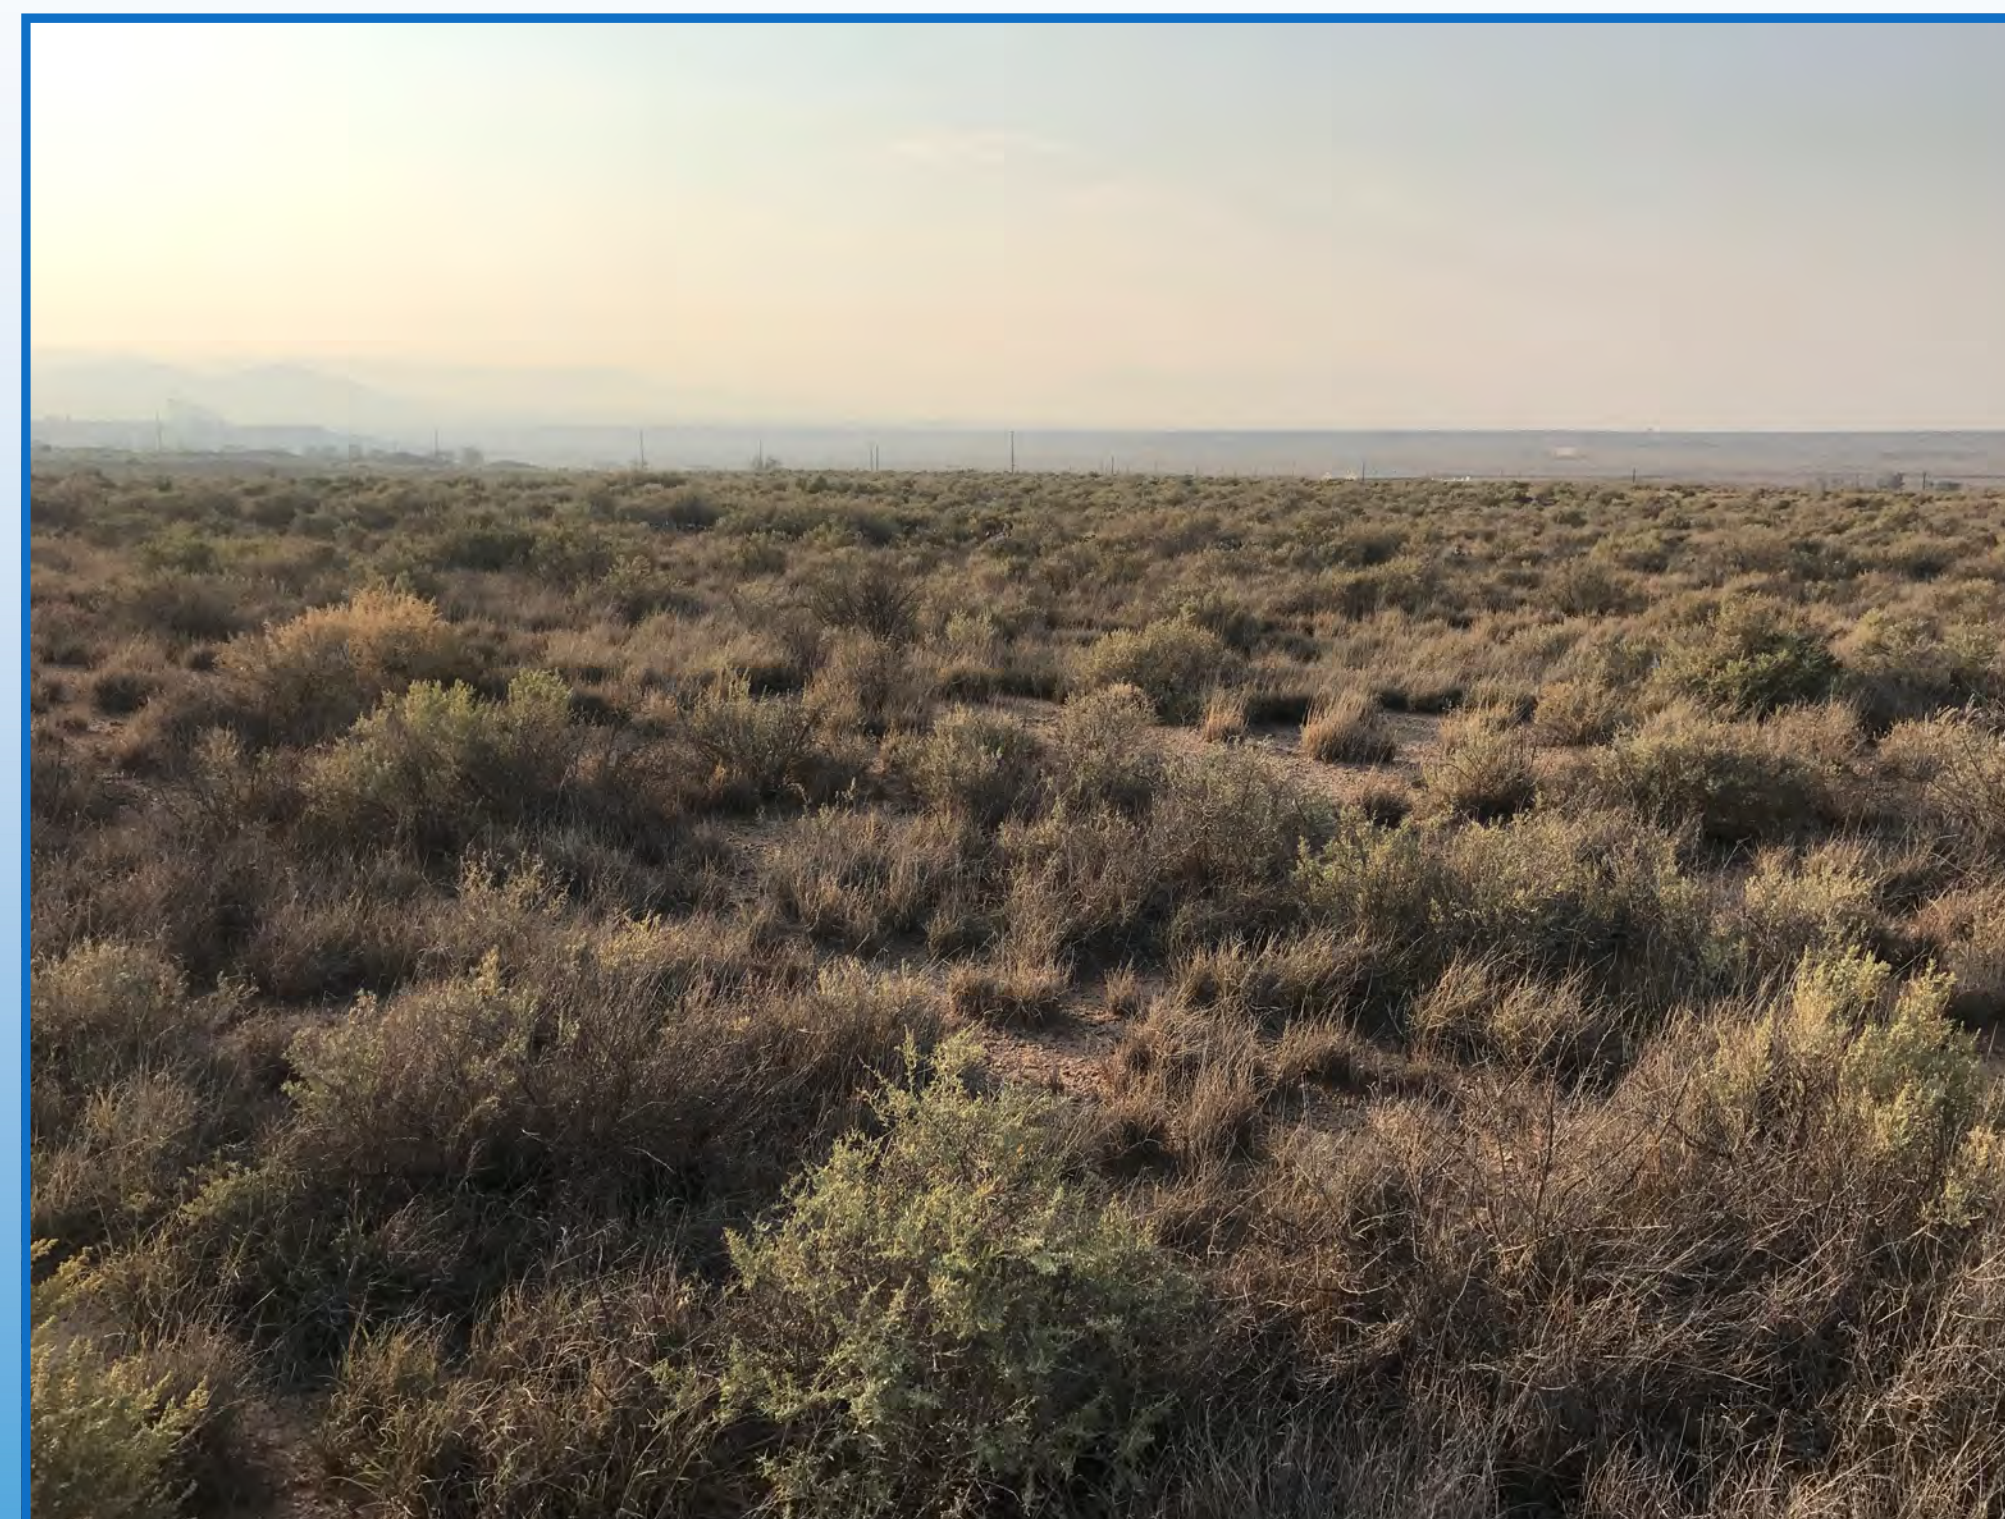
Evapotranspiration (ET) Cover

- Selected as preferred alternative in Corrective Measures Study
- ET cover is 49 acres in area
- ET cover system includes 36" ET cover overlaying a 6" compacted subgrade layer
- Soils for ET cover specified as silty sand, silty-clayey sand, or silty clay, with 99% passing a 1 inch sieve
- Design objective of ET cover was to achieve target percolation rate of 2.5 millimeters per year or less

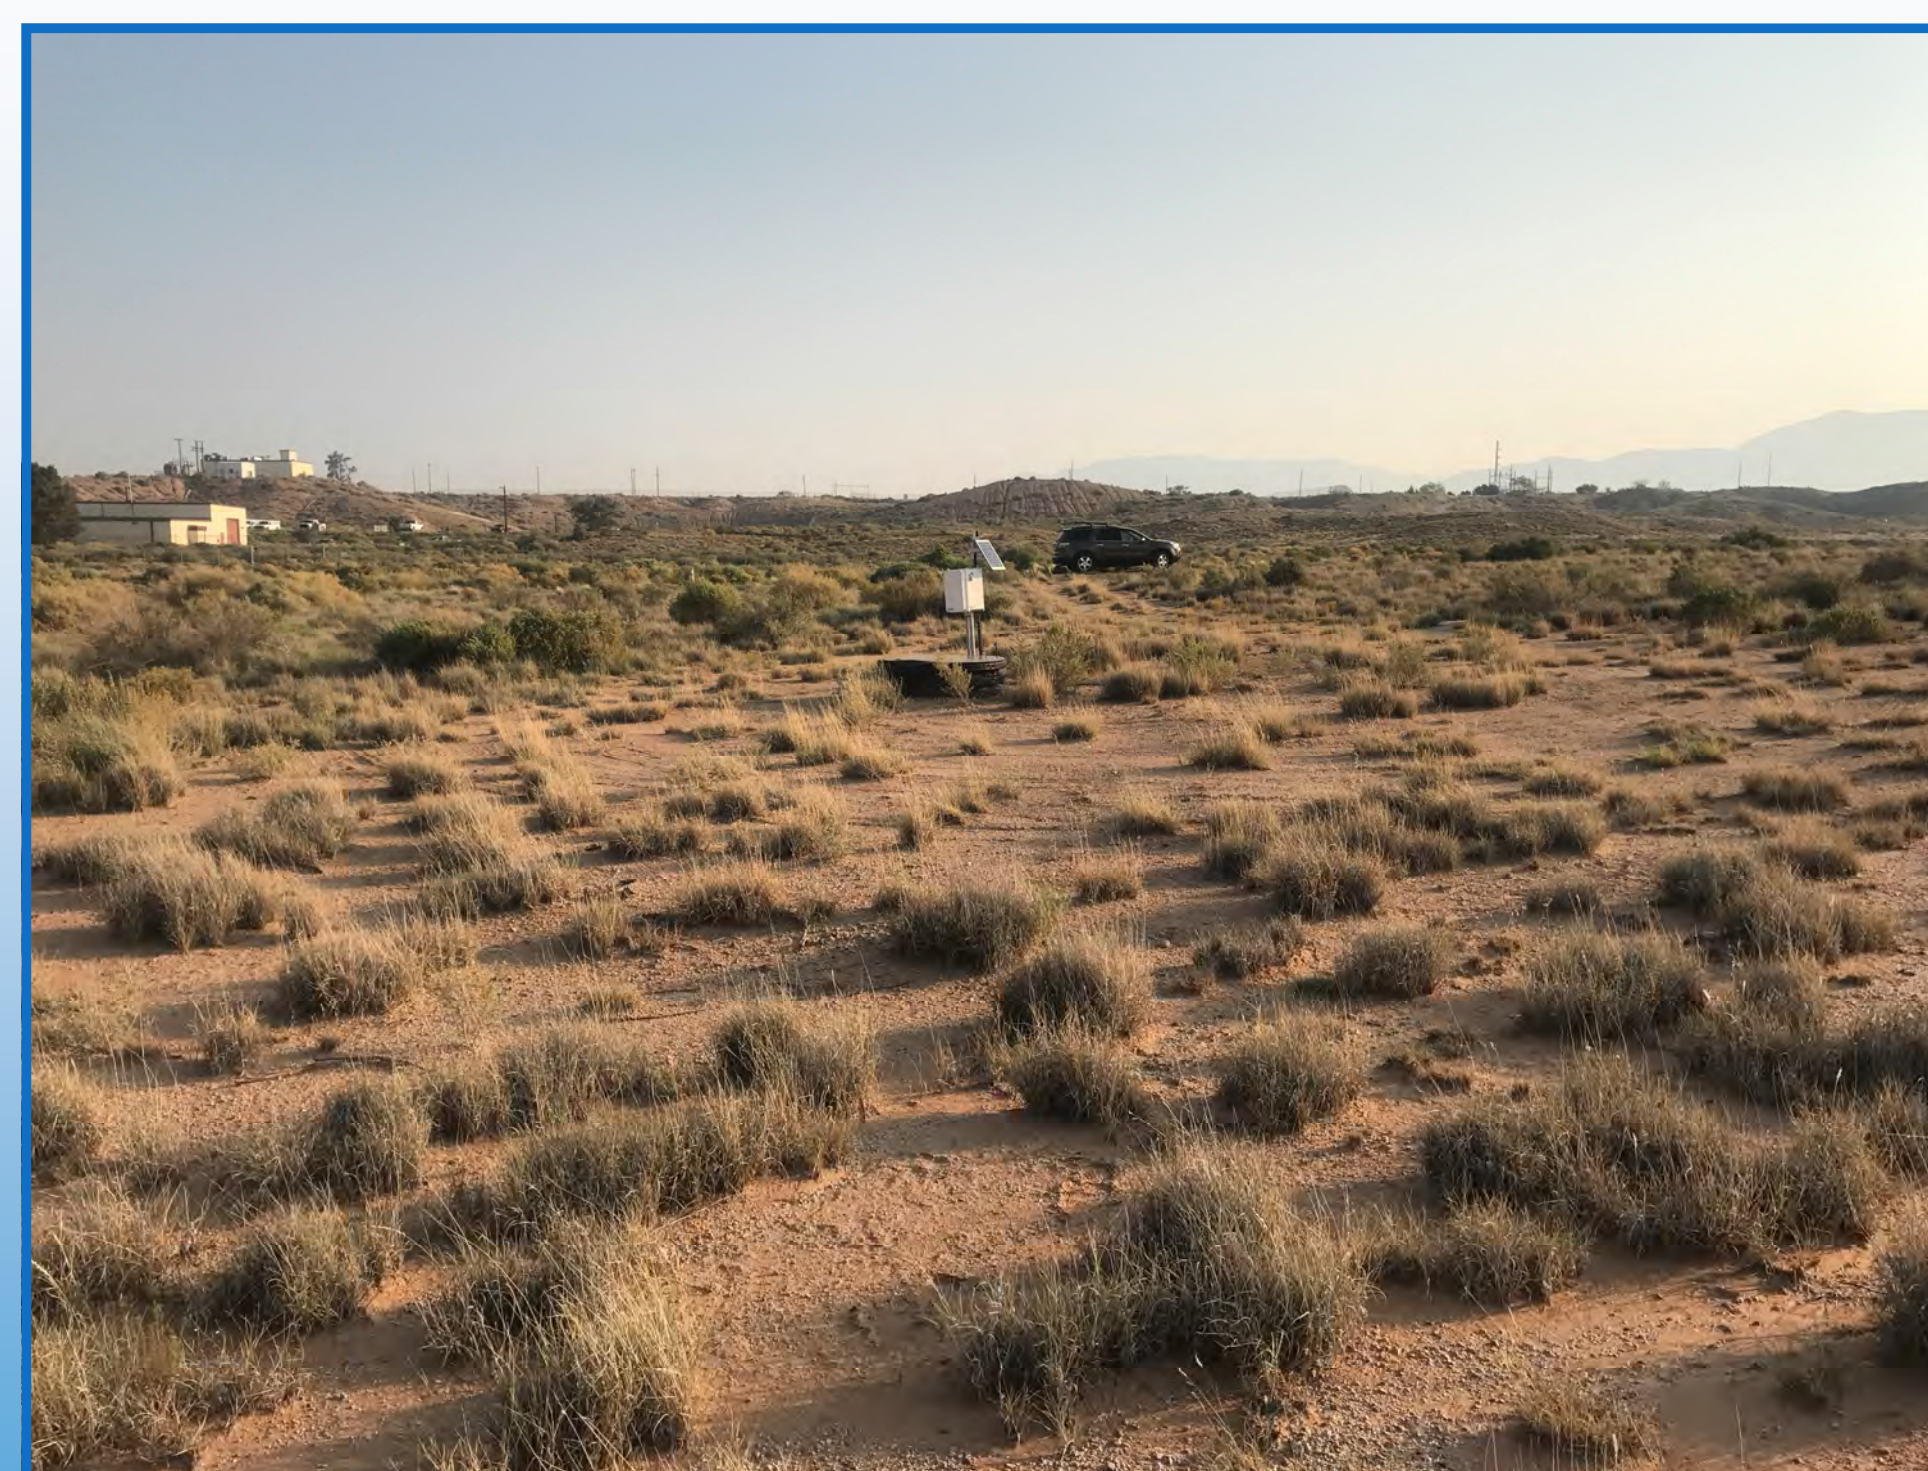
Evapotranspiration (ET) Cover

- Selected as preferred alternative in Corrective Measures Study
- ET cover is 32 acres in area
- ET cover system includes 36" ET cover overlaying a 6" compacted subgrade layer
- Soils for ET cover specified as silty sand, silty-clayey sand, or silty clay, with 99% passing a 1 inch sieve
- Design objective of ET cover was to achieve target percolation rate of 2.5 millimeters per year or less
