KIRTLAND AIR FORCE BASE NATIONAL REGISTER EVALUATION FORM

Address 4499 Biggs Avenue	Base area:	KAFB No 955
Property type: Flight Simulator		Constructed: 1977
Real Estate Name: Training, Flight Simulator	Current Use: Training	Dates: c. 2000 to 2002
Historic Name Flight Simulator Training	Historic Use: School	Dates: 1977 to post 1987

HISTORIC CULTURAL PROPERTIES INVENTORY (HCPI) BASE FORM

HCPI # 43061 NMCRIS # 138110 Project Name: Kirtland AFB HCPI updates Survey Date: June 2017	Agency Number: Kirtland AFB No 955 Other Number: <input type="checkbox"/> Update
NAME OF PROPERTY Historic Name: Flight Simulator Training Current Name: same	OWNER and Contact Information Kirtland AFB Dave Reynolds, CR/NEPA Coordinator (505) 846-0226 david.reynolds.37@us.af.mil
SURVEYOR and Contact Information: Laurel Wallace SWCA Environmental Consultants (505) 254-1115 [updated from the 2003 Van Citters survey]	
PROPERTY TYPE Category: Building Subcategory:	
LAND STATUS Land Status: Federal Agency Specify Other:

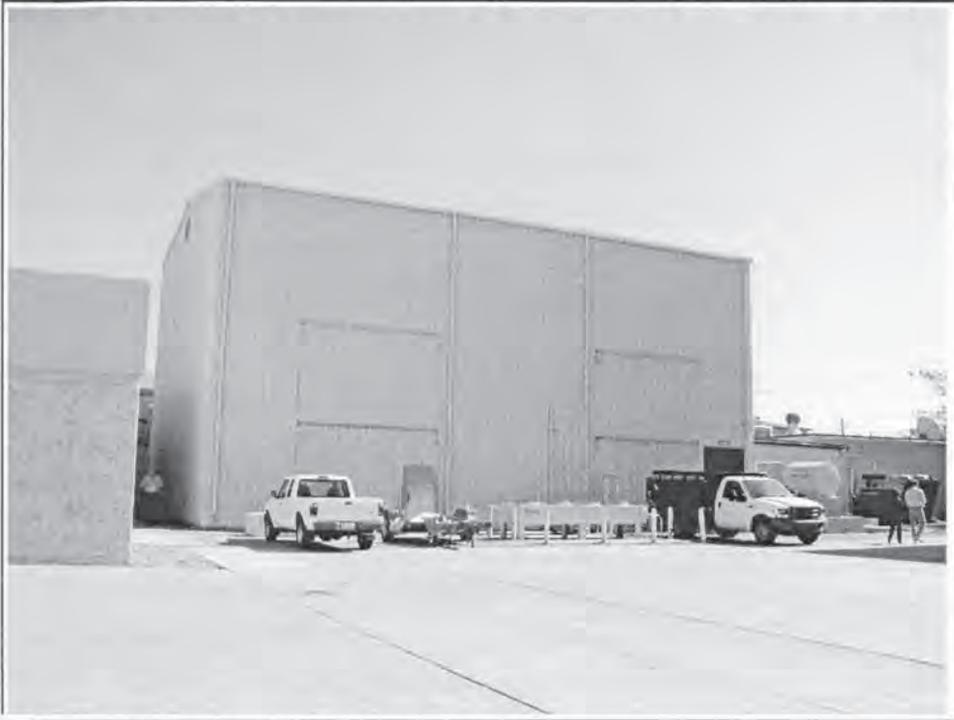
Brief Architectural Description:
 Low gabled metal roof, high bay structure with ribbed metal siding and large bay doors on south. Aluminum gutter and downspouts; metal doors. It is attached to building 952.

Overall the building is in good condition. There are some minor dents at the base.

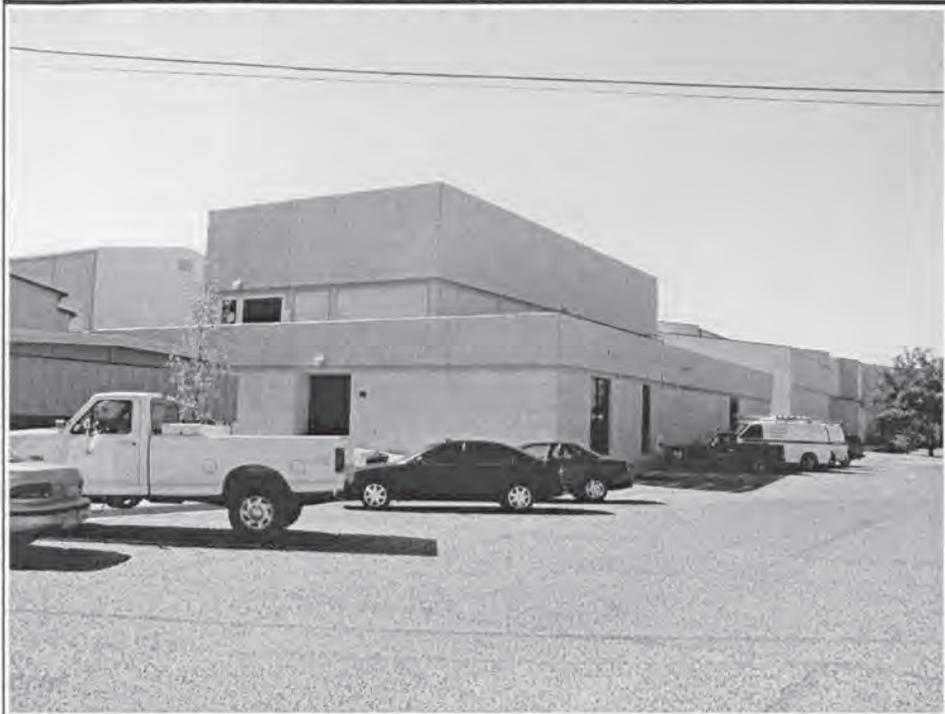
Brief Architectural Description:
 Flat roof with parapet and large stucco band at parapet/roofline. Pebble dash stucco on main wall with anodized aluminum windows.

The building has been well-maintained and no deterioration is visible.

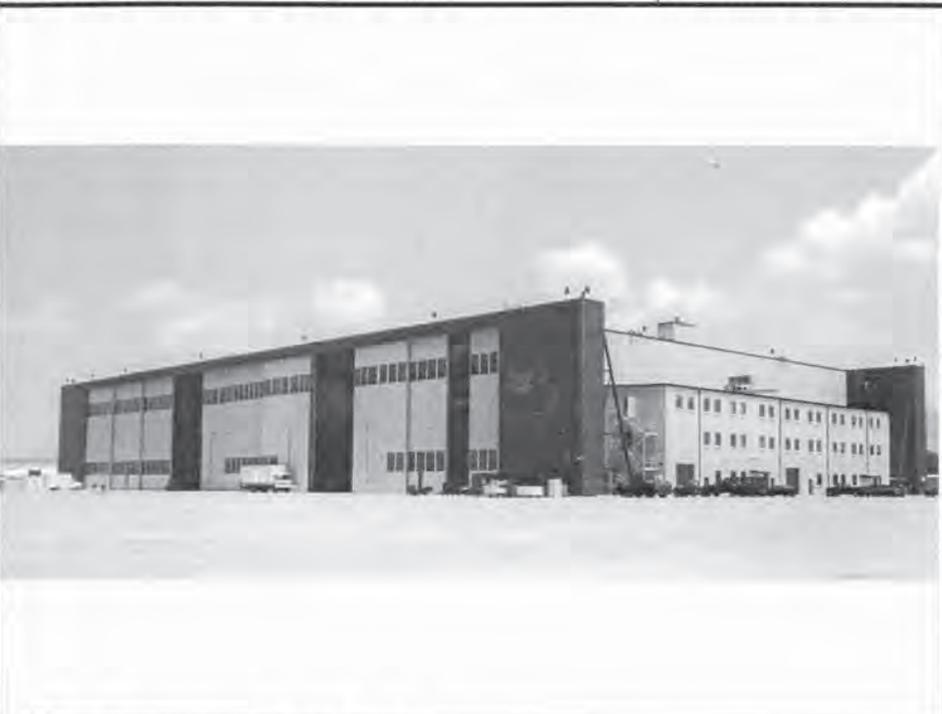
Brief Architectural Description:
 Flat roof with corrugated asbestos siding, sliding bay doors with fixed steel divided light windows and central door for aircraft tail. One story lean-to on north and south elevations.

Building is operated by the 58th SOW and is being well maintained.

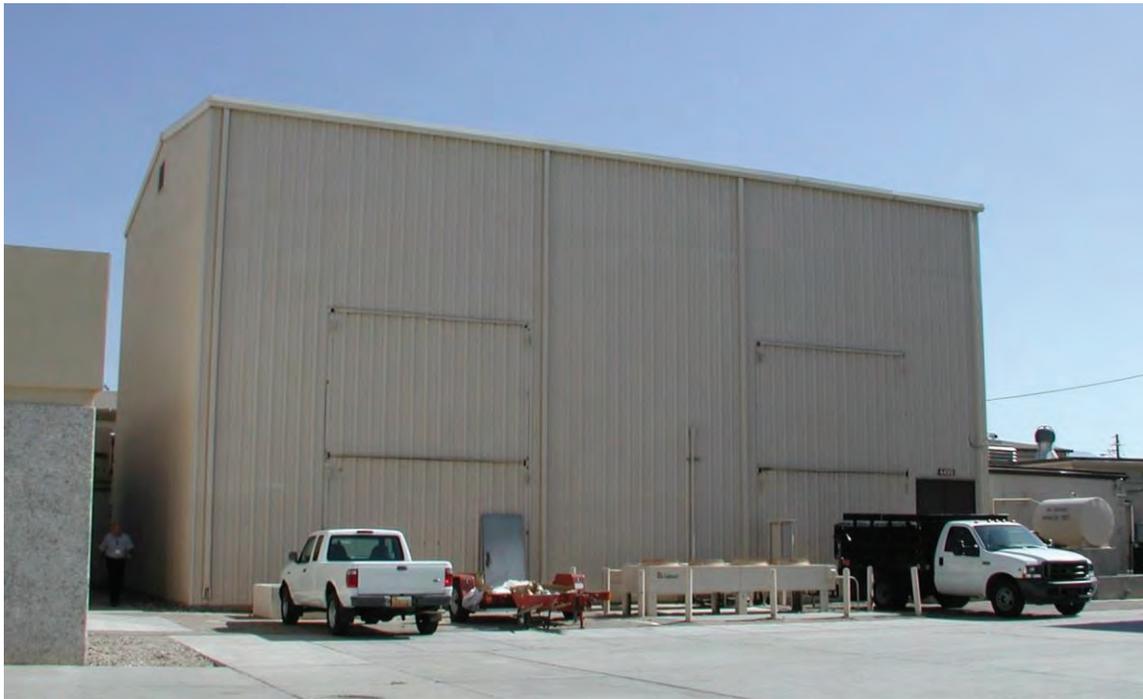
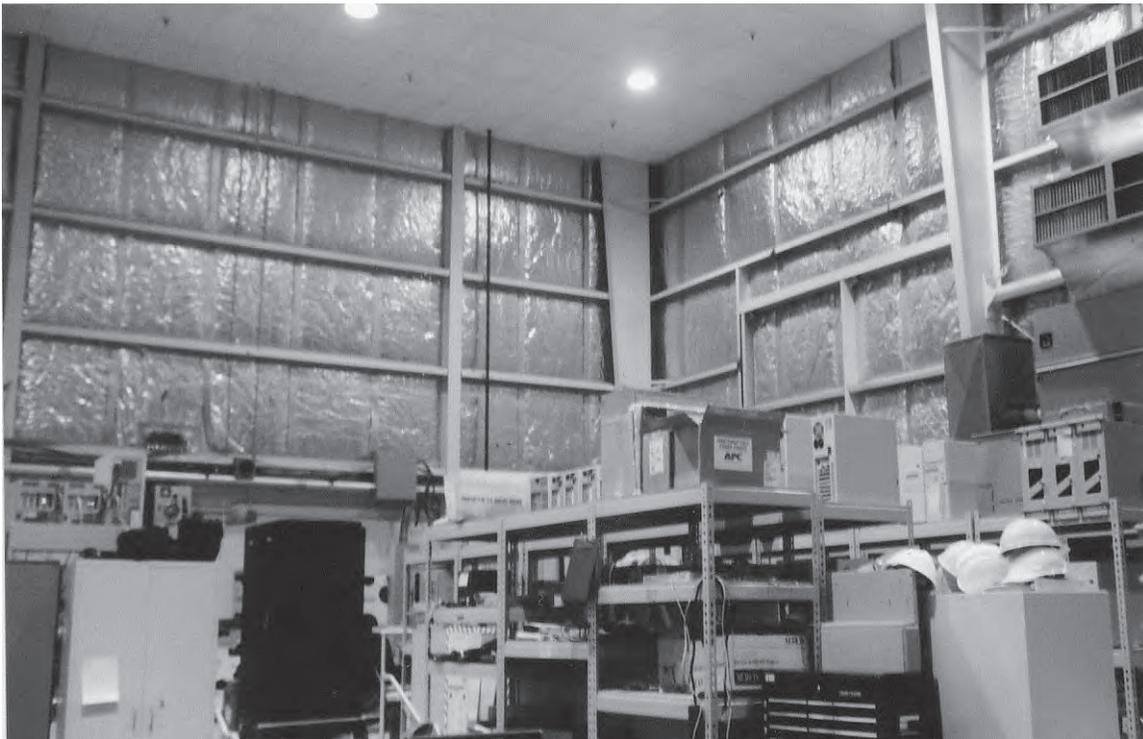
Figures 2-3: photos of KAFB no 955

KAFB no 955 exterior

KAFB no 955, interior

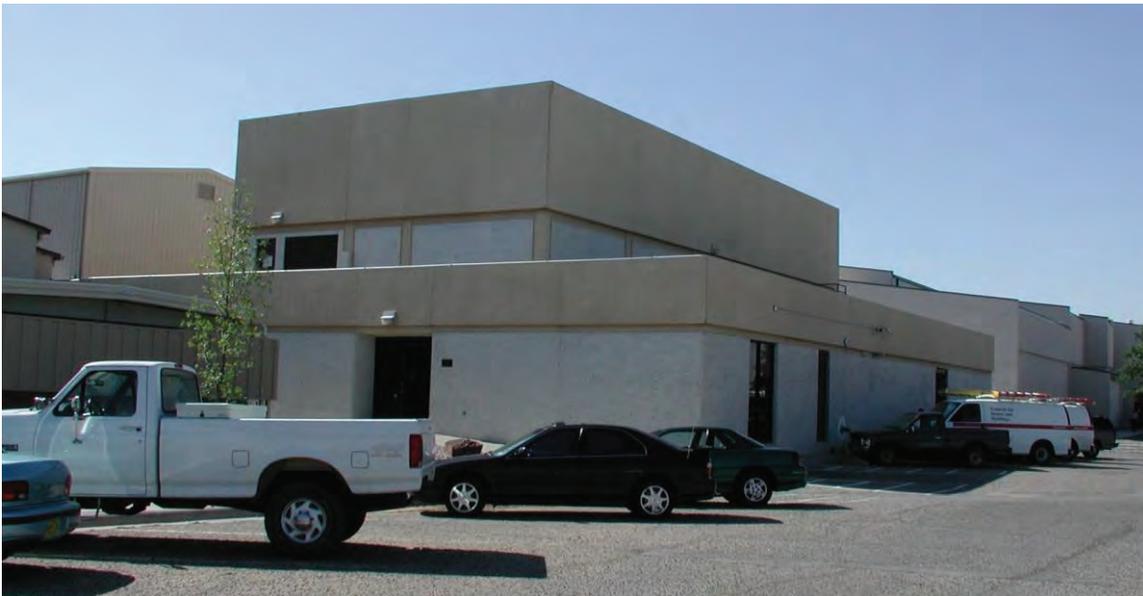
Figure 2: KAFB no 956 exterior

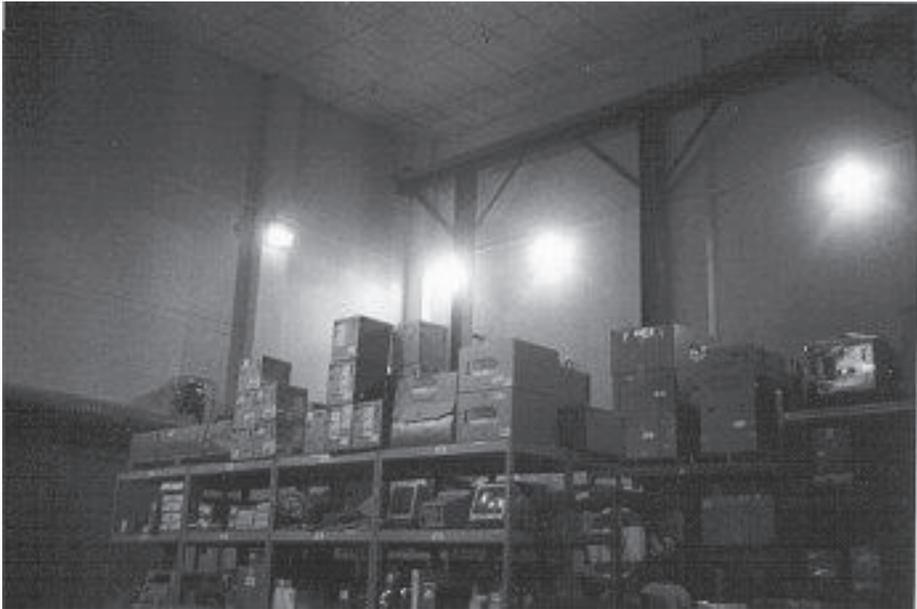
Figure 3: KAFB no 956 interior
