# Air Force Civil Engineer Center

# New Mexico – Arizona PBR

Steve Geiger, P.E., PhD
AECOM Technical
Services
27 Oct 22

# Landfill LF-001, LF-002, LF008

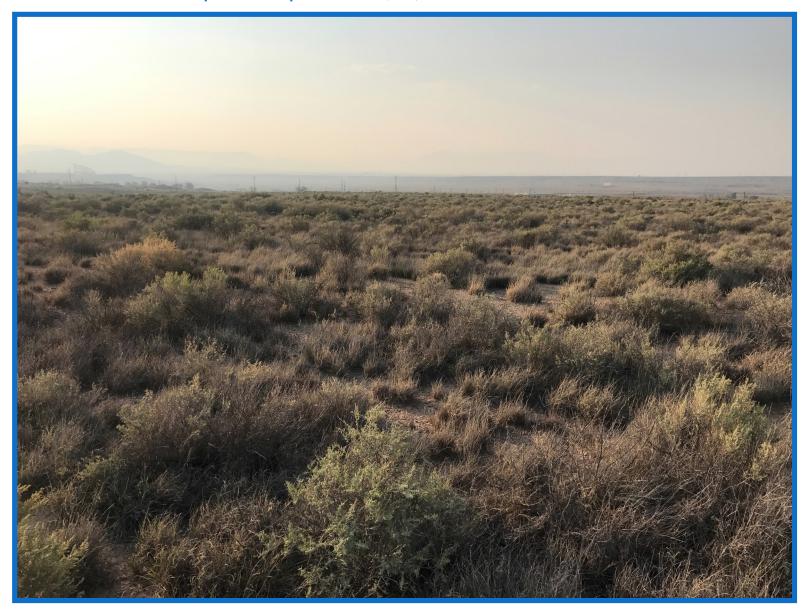
#### Evapotranspiration (ET) Cover – Landfill 1

- > Operated as early as 1951 but primarily between 1960 and 1975
- ➤ Waste was disposed in 'trench-and-fill' fashion
- ➤ Estimated 425,000 cubic yards (CY) of municipal waste and 175,000 CY of construction waste and demolition debris
- ➤ Depth to groundwater ranges from 420 to 450 feet
- Currently four regional aquifer groundwater monitoring wells
- ➤ Long-Term Monitoring (LTM) program initiated in 1996
- > Evapotranspiration (ET) cover installation completed in 2006

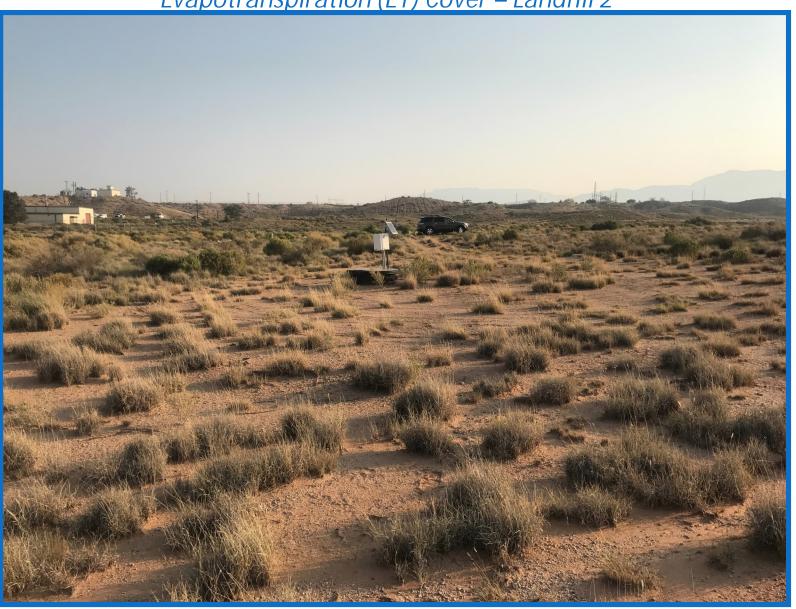
Evapotranspiration (ET) Cover – Landfill 2

- Operated between 1942 and 1965
- ➤ Waste was disposed in 'trench-and-fill' fashion
- ➤ Estimated 1,321,700 cubic yards (CY) of general refuse, construction and demolition debris
- ➤ Depth to groundwater ranges from 370 to 415 feet
- ➤ The Water Authority's 21-inch Tijeras Interceptor sanitary sewer line crosses the site
- > Currently six regional aquifer groundwater monitoring wells
- ➤ Long-Term Monitoring (LTM) program initiated in 1996
- ➤ Tijeras arroyo was modified in 1999 to reduce flooding potential at LF-002 under the 100-yr runoff event

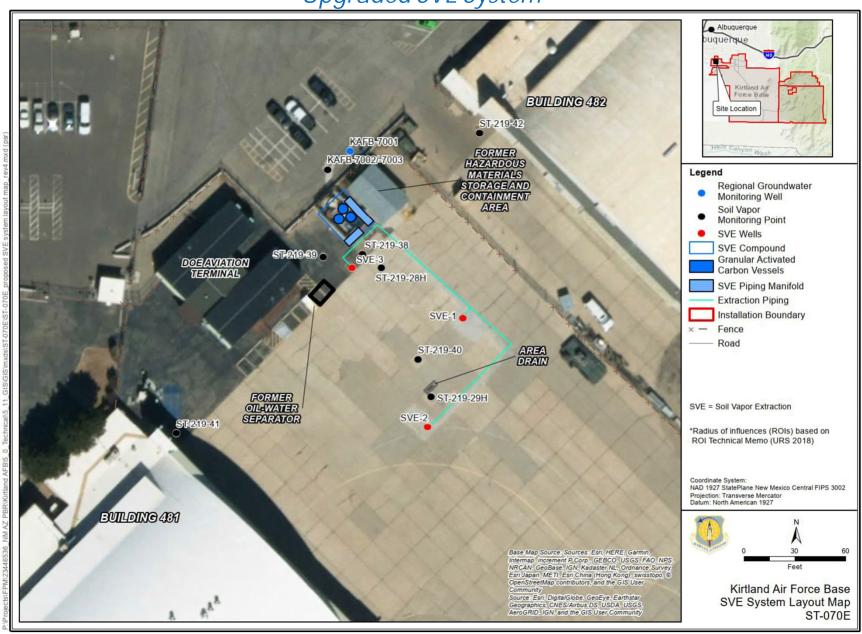
#### **Upgraded SVE System**

- ➤ 2016 SVE Treatment System Upgrade:
  - > 20 HP SVE blower up to 250 scfm operating at vacuum of 90 inches of water column
  - ➤ Two 3,000 lb vapor phase granular activated carbon (GAC) treatment vessels
- Mass Removal From SVE Upgraded System (March 2018 through May 2019)
  - > TPH (gasoline range) 9,760 lbs
  - ➤ Tetrachloroethylene (PCE) 5.2 lbs
  - ➤ Trichloroethylene (TCE) 15.3 lbs
  - ➤ Benzene 0.002 lbs

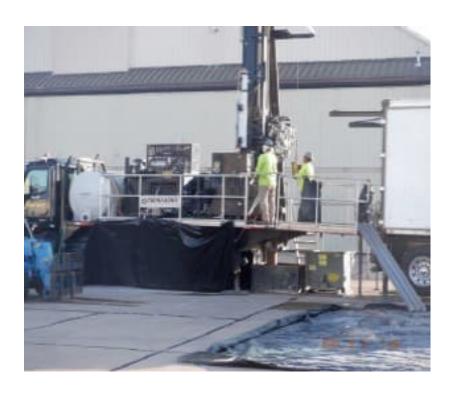
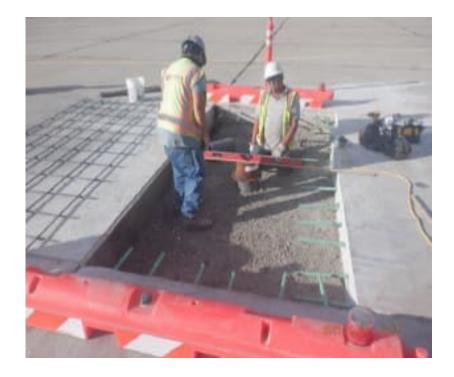
- ➤ Installation of groundwater monitoring wells KAFB-7004 and KAFB-7005 (2021)
  - > Two down-gradient, 4" wells installed in Sept. 2021 (~460 ft total depth)

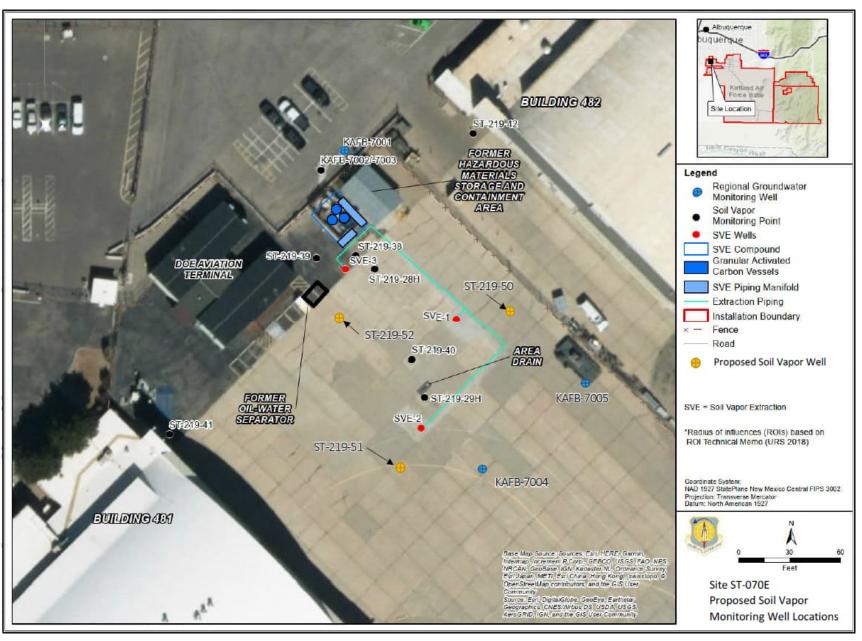
#### New and Planned Wells

- Three new soil-vapor monitoring (SVM) wells planned
  - ➤ Three SVM well borings with 7 sampling intervals (2 triple nested and 1 single nested) will be installed at locations proximate to the 2016 SVE wells
  - The ST-070E SVM Well Work Plan is currently under NMED review
  - ➤ The Work Plan includes a requirement for annual sampling of all Site ST-070E SVM wells
