# Semi-Annual Public Meeting

# New Mexico – Arizona PBR

Steve Geiger, P.E., PhD AECOM Technical Services 28 Apr 22

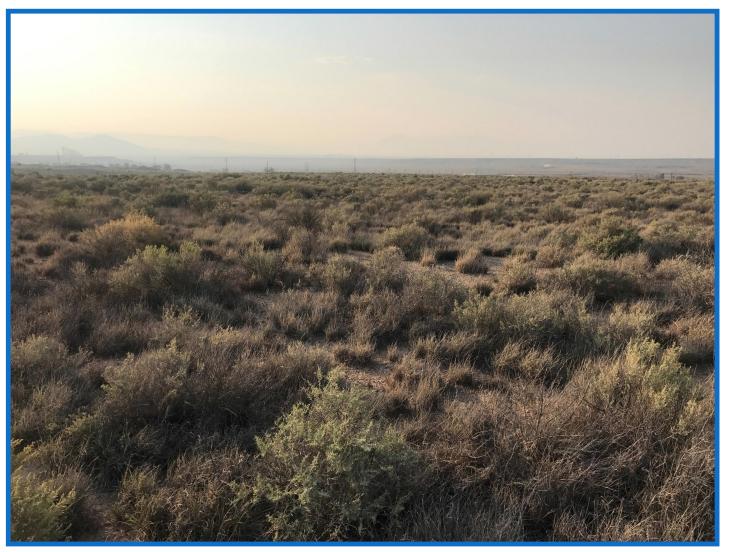
Evapotranspiration (ET) Cover – Landfill 1

- > Operated as early as 1951 but primarily between 1960 and 1975
- Waste was disposed in 'trench-and-fill' fashion
- Estimated 425,000 cubic yards (CY) of municipal waste and 175,000 CY of construction waste and demolition debris
- Depth to groundwater ranges from 420 to 450 feet
- Currently four regional aquifer groundwater monitoring wells
- Long-Term Monitoring (LTM) program initiated in 1996
- Evapotranspiration (ET) cover installation completed in 2006

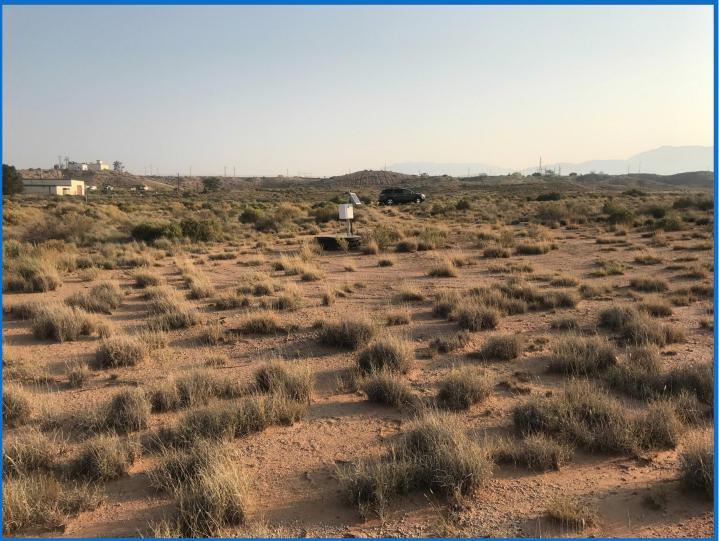
Evapotranspiration (ET) Cover – Landfill 2

- Operated between 1942 and 1965
- ➤ Waste was disposed in 'trench-and-fill' fashion
- Estimated 1,321,700 cubic yards (CY) of general refuse, construction and demolition debris
- Depth to groundwater ranges from 370 to 415 feet
- The Water Authority's 21-inch Tijeras Interceptor sanitary sewer line crosses the site
- > Currently six regional aquifer groundwater monitoring wells
- Long-Term Monitoring (LTM) program initiated in 1996
- Tijeras arroyo was modified in 1999 to reduce flooding potential at LF-002 under the 100-yr runoff event

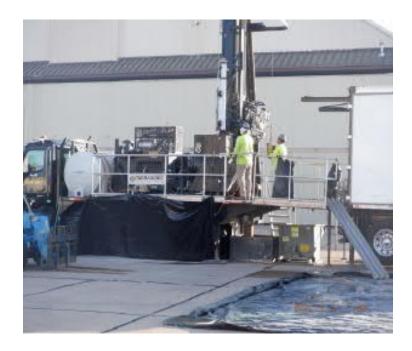
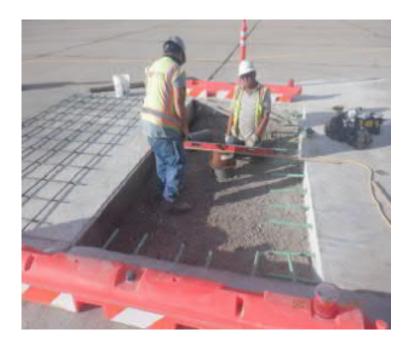
- Installation of groundwater monitoring wells KAFB-7004 and KAFB-7005 (2021)
  - Two down-gradient, 4" wells installed in Sept. 2021 (~460 ft total depth)

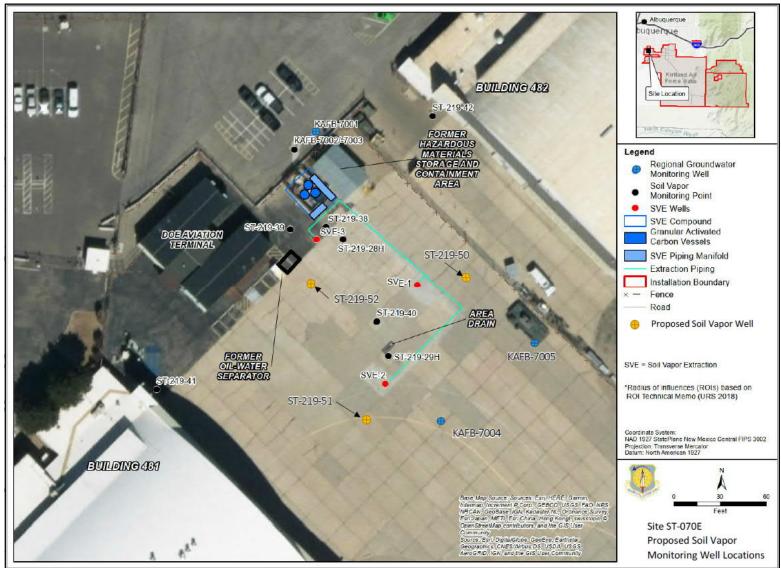
#### New and Planned Wells

- Three new soil-vapor monitoring (SVM) wells planned
  - Three SVM well borings with 7 sampling intervals (2 triple nested and 1 single nested) will be installed at locations proximate to the 2016 SVE wells
  - ➤ The ST-070E SVM Well Work Plan is currently under NMED review
  - The Work Plan includes a requirement for annual sampling of all Site ST-070E SVM wells

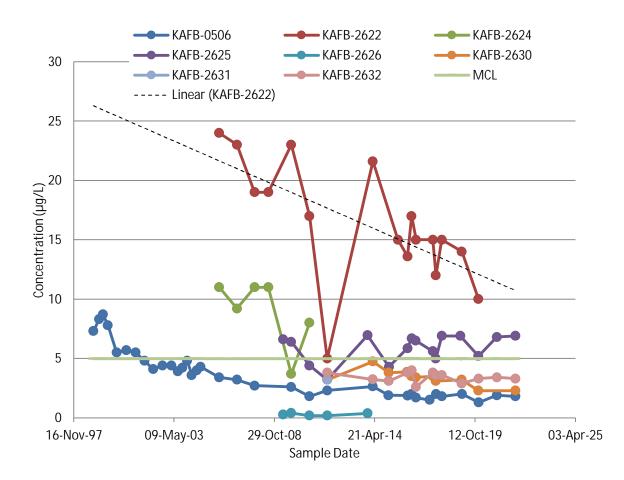
#### Perched Unit Groundwater TCE Trends

- Sampled annually for anions (including nitrate), TAL metals, VOCs
- TCE only constituent exceeding groundwater standards (wells KAFB-2622 and KAFB-2625 occasionally)
- ➢ Significant decreasing concentration trend in well of highest concentration (KAFB-2622, at 10 µg/L in 2020)
- ➢ Well KAFB-2622 went dry in 2021
- Strong trend in declining water levels in wells (~ 1 ft/year on average); 4 perched unit wells have gone dry, 4 wells still being sampled

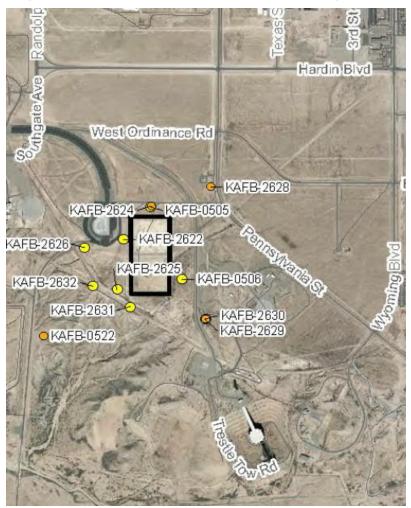
#### Regional Groundwater Monitoring Wells

- > 4 wells sampled annually for anions (including nitrate), TAL metals, VOCs
- ➤ All VOC samples "non-detect"
- Well KAFB-0522 has intermittently had nitrate exceedances this well is upgradient of the Site WP-026 and is related to Site ST-105 nitrate
